## APPENDIX 1: SITE INVENTORY

### Tyne and Wear HER Entries

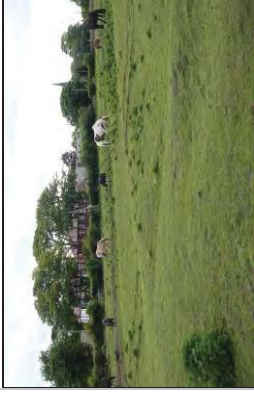
| HER No | Site Name | NGR | Description | Period | Sources | Photo |
|---|---|---|---|---|---|---|
| 973 | Ridge and furrow on the east and south side of the township | NZ 38 62 | Ridge and furrow survives as earthworks, or on air photos, north (NZ 38 63) and north-east (NZ 39 63) of Cleadon village, on what were named as North Field and Cleadon Lizards on the 1st ed. OS 6". There are traces east of the village, on both sides of Cleadon Lane in East Field, and on what survives of Cleadon's share of Boldon Flats called Cleadon Moor on the 1st ed. 6" {1 and 2}. Area retains considerable ridge and furrow, with what appear to be large ditched boundary banks. The ridge and furrow at Boldon Flats and that between East Farm and Undercliff at Cleadon is on South Tyneside Council's Local List. | Medieval/Post-Medieval | 1st edition Ordnance Survey Map, c.1862; Durham IV/ VIII Aerial Photograph, South Tyneside Planning Dept., 1981 Pers. Comm. S. Speak, Tyne and Wear Museums, 1992; Aerial Photograph, Geonex, 1991 10791/010 07/09/1991; Aerial Photograph, Air Fotos, 1989 903-1793-6, 905-1834-8, 904-1815-9; SOUTH TYNESIDE LOCAL LIST REVIEW 2011: REFERENCE NUMBER: LSHA/133/B and LSHA/154/C CVA landscape and building survey 2013-14 | |

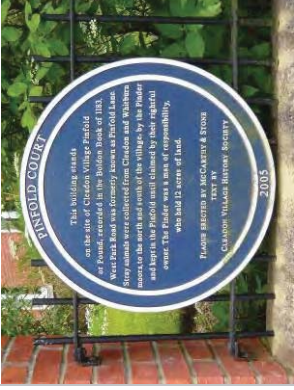
| HER No | Site Name | NGR | Description | Period | Sources | Photo |
|---|---|---|---|---|---|---|
| 12761 | Boldon Lane, pound | NZ 3808 6228 | The Boldon Book of 1183 mentions Cleadon pound or pinfold. From at least the 18th Century the pound was located at the junction of West Park Road (formerly Pinfold Lane) and Boldon Lane. Today there is a plaque and seat at the road junction to commemorate it. | Medieval | South Tyneside Council, 2007, Cleadon Conservation Area Character Appraisal, page 8; D. Wawn, no date, Notes on the Antiquities of Cleadon | |

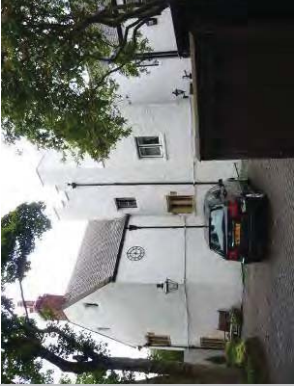
| HER No | Site Name | NGR | Description | Period | Sources | Photo |
|---|---|---|---|---|---|---|
| 964<br>(and 8026) | Cleadon tower | NZ 385 624 | Cleadon Tower is believed to be mentioned as early as 1587 and is perhaps rather a rare instance of a tower standing on a copyhold estate. The tower was taken down by Richard Pemberton, Esq. in the late 18th Century. The current 'tower' dates to 1890, although the surrounding buildings are earlier.. | Medieval | R. Surtees, 1820, History...of Durham, II, 55 and n.<br>1839 Tithe DDR/EA/TTH/1/252<br><b>Grade II Listed</b> (List No. 1025211)<br>CVA Building Survey but NEVAG Cleadon Tower Building Survey NAA & NEVAG Rpt 15-03. | |

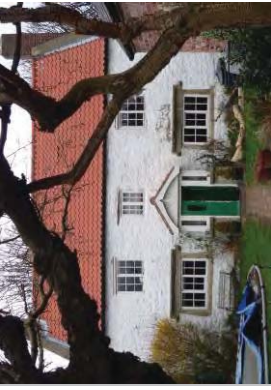
| HER No | Site Name | NGR | Description | Period | Sources | Photo |
|---|---|---|---|---|---|---|
| 8051 | Front Street, No. 11 | NZ 3850 6243 | Briar Cottage House, a mid C17, grade II listed building. Roughly squared coursed limestone, roof of pantiles. 2 storeys, 3 bays. Central half-glazed door with blank wall over between 3-light stone- mullioned windows with hood-moulds; 2 mullioned windows of 2 lights with hood-moulds at first floor. | 17th-century | Department of National Heritage, List of Buildings of Special architectural or Historic Interest, 3/19<br>1839 Tithe DDR/EA/TTH/1/252<br>CVA Building Survey 2013<br><b>Grade II Listed Building</b> | |

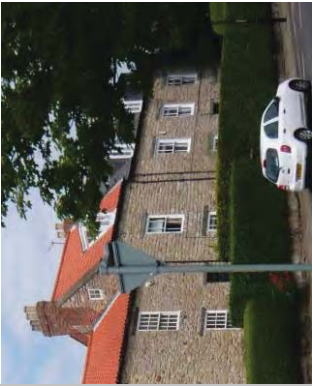
| HER No | Site Name | NGR | Description | Period | Sources | Photo |
|---|---|---|---|---|---|---|
| 8048 | Front Street, No. 1 | NZ 3854 6242 | Grade II listed farmhouse and hind cottage. Late C17/early C18. Coursed squared limestone, the main house thinly rendered; roof of Welsh slates to the main house, pantiles to the cottage. Main house: 2 storeys, 3 bays; central boarded door with oblong fanlight, sash windows at either side on ground floor; first floor has 2 sash windows and blocked narrow central window. Roof has 3 segment-headed dormers blocked with plywood at time of survey; 2 end brick chimneys. Cottage-: 2 storeys, 2 bays; one sash window at left; at right, one blocked narrow window on first floor. | 17th-century | Department of National Heritage, List of Buildings of Special architectural or Historic Interest, 3/15<br><b>Grade II Listed Building</b> (List No. 1025250)<br>1839 Tithe DDR/EA/TTH/1/252<br>South Tyneside Council, 2007, Cleadon Conservation Area Character Appraisal<br>CVA Building Survey 2013 | |

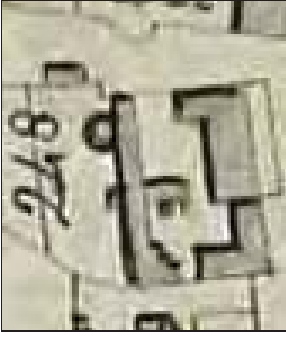
| HER No | Site Name | NGR | Description | Period | Sources | Photo |
|---|---|---|---|---|---|---|
| 12762 | Burdon Farm | NZ 3853 6243 | Burden's Farm lay north of the village pond. Some farm buildings still survive. | 17th-century (possibly earlier) | South Tyneside Council, 2007, Cleadon Conservation Area Character Appraisal, page 8<br>1839 Tithe DDR/EA/TTH/1/252<br>1st edition Ordnance Survey Map, c.1862, 6-inch scale, Durham, 3<br>CVA Building Survey 2014 | |

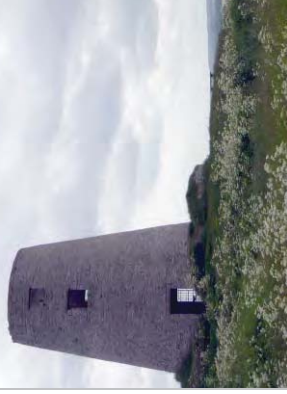
| HER No | Site Name | NGR | Description | Period | Sources | Photo |
|---|---|---|---|---|---|---|
| 1587 | Cleadon Windmill | NZ 3893 6318 | 18th-century tower mill built of coursed limestone rubble rising from a low mound contained by a retaining wall of limestone. The tower stands roofless with cap and sails removed but the stone shell is intact with one or two floor joists still in place. All the openings have dressed sandstone outer and timber inner lintels. Part of the cugged track on which the cap of the windmill turned is still visible. | 17th-century in origin - current building date to late 18th-century | I. Ayris & P. Jubb, 1987, Tower Mills of South Tyneside<br>I. Ayris & S.M. Linsley, 1994, A Guide to the Industrial Archaeology of Tyne and Wear<br><b>Grade II Listed Building (List No. 1025192)</b><br>1839 Tithe DDR/EA/TTH/1/252<br>CVA Cleadon Mill Excavations – NAA Report No. 15-02<br>CVA landscape and building survey 2013-14 | |

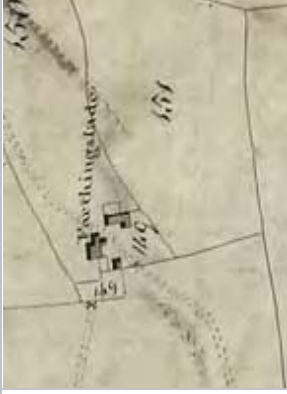
| HER No | Site Name | NGR | Description | Period | Sources | Photo |
|---|---|---|---|---|---|---|
| 965 | Farding Slade Farm | NZ 3920 6429 | In 1647 Elizabeth, widow of Robert Chambers, held land etc. listed under the heading "Whitburne cum Cleyton Copyholds". This land included "16 riggs of land in Cleadon in a certain place there called Farthing Slayde". The status of this place in the mid C17 is unknown, and also, indeed, whether it might be medieval. It underwent extensive modification and rebuilding in the mid 19th Century when occupied by Robert Jefferson. Site was cleared in the 1980s | 17th-century? | D.A. Kirby, 1972, Parliamentary Surveys of the Bishopric of Durham, Surtees Society, II, 185, p. 50<br>W. Parson & W. White, 182, Directory of Durham and Northumberland, II, pp. 199-200<br>Ordnance Survey maps, 1862, 1st ed. 6, Durham IV<br>1839 Tithe DDR/EA/TTH/1/252<br>CVA Landscape Survey 2013 | |

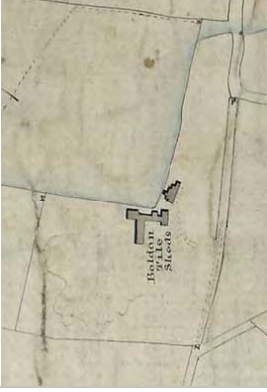
| HER No | Site Name | NGR | Description | Period | Sources | Photo |
|---|---|---|---|---|---|---|
| 1582 (and 2317) | Tilesheads Farm Brick Kilns | NZ 3652 6208 | 'Brick Works' first shown on Armstrong's 1791 map and appearing later on the 1839 tithe and 1st edition Ordnance Survey map. Featured a pair of horizontal through draught kilns surviving on a site otherwise cleared of its former buildings and now host to a piggery. Three 19th century brick making sites were situated within a quarter of a mile radius in this area. The surviving kilns, recorded in 1994, | 17th-century? | Armstrong 1791<br>1839 Tithe DDR/EA/TTH/1/252<br>1st edition Ordnance Survey map, 1854<br>I. Ayris & S.M. Linsley, 1994, A Guide to the Industrial Archaeology of Tyne and Wear, p 45<br>CVA landscape and building survey | |

| HER No | Site Name | NGR | Description | Period | Sources | Photo |
|---|---|---|---|---|---|---|
| | | | were demolished. Now forms part of the Tiledsheds Nature reserve, the flooded clay pits providing wonderful wetland habitat. | | 2013-14 | |

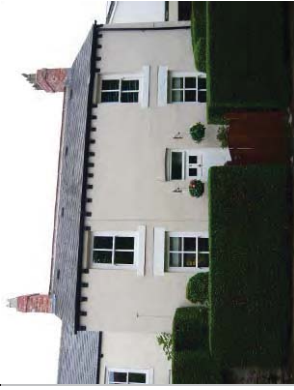
| HER No | Site Name | NGR | Description | Period | Sources | Photo |
|---|---|---|---|---|---|---|
| 12777 | Sunnyside Lane,<br>No. 5 | NZ 3854 6245 | Late 18th- to early 19th- century house probably incorporating the remains of earlier structures. Rendered front elevation that returns along the first floor of the south facing gable. A pleasant building with brick corbelling supporting rainwater goods, brick quoins and timber four-pane sliding sash windows on the first floor and three-over-two on the ground floor. | 18th-century | South Tyneside Council, 2007, Cleadon Conservation Area Character Appraisal, page 30<br>CVA Building Survey 2014<br>1839 Tithe DDR/EA/TTH/1/252 | |

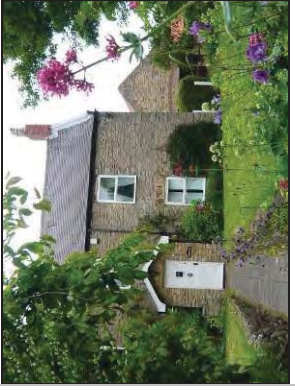
| HER No | Site Name | NGR | Description | Period | Sources | Photo |
|---|---|---|---|---|---|---|
| 9606 | Cleadon Lane,<br>No. 1, East Farm<br>and boundary<br>walls | NZ 3857 6242 | The farm comprised two yard areas and a collection of outbuildings including a gin-gang. The late 18th and early 19th Century farmhouse (NZ 3857 6242) is built in irregular coursed rubble with irregular stone quoins. It has new window openings and window inserts that are flush to the wall. The roof is Welsh slate with high raised gables.<br>The farmhouse is surrounded by an attractive stone boundary wall and is a prime example of the use of the local limestone and glacial erratics as a building material. The new East Farm development is a courtyard with modern houses around it. | 18th-century<br>(possibly<br>medieval in<br>origin) | Tyne and Wear Specialist<br>Conservation Team, March 1992,<br>Other Buildings of Acknowledged<br>Architectural Quality or Historic<br>Significance (South Tyneside UDP<br>Appendix ENV (B)); South Tyneside<br>Council, March 2007, Cleadon<br>Conservation Area Character<br>Appraisal Tyneside Local List Review<br>2011, LSHA/147/C<br>1839 Tithe DDR/EA/TTH/1/252<br>CVA Building Survey 2014 | |

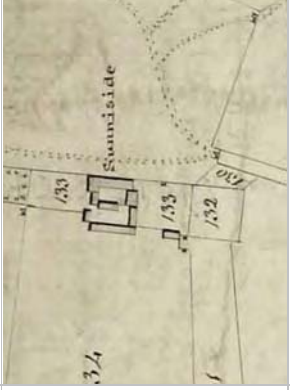
| HER No | Site Name | NGR | Description | Period | Sources | Photo |
|---|---|---|---|---|---|---|
| 9099 | Sunnyside Farm | NZ 3864 6342 | A discreet group of functional buildings in local limestone and slate. In good condition with recent lime-rich pointing. Single high brick arched entrance into the courtyard. The farmhouse is a simple square hip roofed building with regular fenestration. Farm appears on 1839 tithe map and was one of the post-enclosure farmsteads established in the late 17th Century. | 18th-century<br>(probably 17th<br>century in origin) | South Tyneside Council, 2007,<br>Cleadon Hills Conservation Area<br>Character Appraisal<br>CVA Building Survey 2014 | |

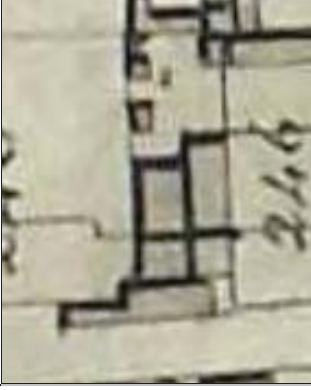
| HER No | Site Name | NGR | Description | Period | Sources | Photo |
|---|---|---|---|---|---|---|
| 12765 | Cleadon Old Hall | NZ 3846 6243 | A large 18th-century three bay mansion house. Set within landscaped grounds with a woodland edge. Demolished in the 1960s. Replaced with flats of the same name. One or two trees survive from the garden of the Old Hall. Original house probably built for John Burdon who later moved to Hardwick Park. | 18th-century | South Tyneside Council, 2007, Cleadon Conservation Area Character Appraisal<br>1839 Tithe DDR/EA/TTH/1/252<br>CVA Building Survey 2014 | |

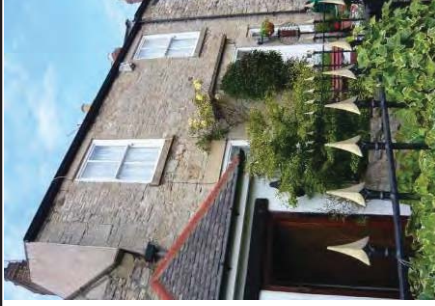
| HER No | Site Name | NGR | Description | Period | Sources | Photo |
|---|---|---|---|---|---|---|
| 8153 | Cleadon, Front Street, No. 5 | NZ 3852 6241 | House. 18th-century. Roughly coursed inestone rubble, Welsh slate roof. 2 storeys, 2 windows with late C19 sashes; later central projecting porch has boarded door and oblong fanlight. Stone gable copings, 2 end brick chimneys. Rear elevation: red brick, 2 periods, similar first floor windows, modern ground floor windows and door. Included partly for group considerations. | 18th-century | Department of National Heritage, List of Buildings of Special architectural or Historic Interest, 3/17<br><b>Grade II Listed Building</b> (List No. 1299739)<br>CVA Building Survey 2014 | |

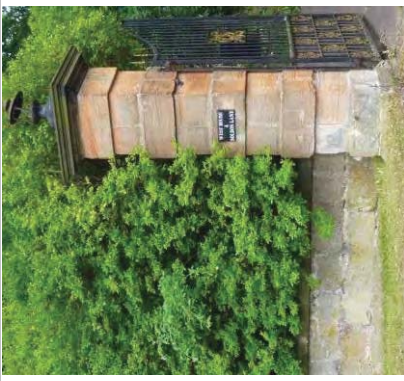
| HER No | Site Name | NGR | Description | Period | Sources | Photo |
|---|---|---|---|---|---|---|
| 8027 | Cleadon House boundary walls and gate piers | NZ3831762324 | Cleadon House wall and gate piers. Arising from front right of the house is a high brick wall with 3 banded square piers and a garden entrance; this connects with a high garden wall, extending the width of the garden, of roughly squared coursed limestone rubble with a triple moulded brick coping. The entrance from the street is formed by a low wall of brick with stone coping, continuing along through 3 square brick piers with plinths, in which are 2 ashlar gate piers with overhanging cornices. Original iron gates and railings have been removed. | 18th-century | English Heritage National List<br><b>Grade II Listed Building (List No. 025213)</b><br>1st edition Ordnance Survey Map, c.1862, 6-inch scale<br>1839 Tithe DDR/EA/TTH/1/252<br>CVA Building Survey 2014 | |

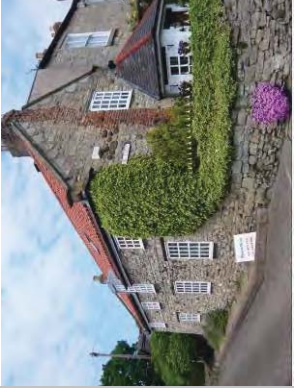
| HER No | Site Name | NGR | Description | Period | Sources | Photo |
|---|---|---|---|---|---|---|
| 8049 | Front Street, No. 7 | NZ 3851 6241 | Former Wesleyan Methodist Chapel, which occupied an earlier farm building. Early C18 in date built of roughly coursed limestone rubble and orientated north to south away from the line of Front Street. Chimney at gable end, which has been repaired with hand-made red brick. Recently renovated and now a house. | 18th-century (possibly 17th-century) | Department of National Heritage, List of Buildings of Special architectural or Historic Interest, 3/18<br>1839 Tithe DDR/EA/TTH/1/252<br><b>Grade II Listed Building</b> (List No. 1025251)<br>South Tyneside Council, 2007, Cleadon Conservation Area Character Appraisal<br>CVA Building Survey 2014 | |

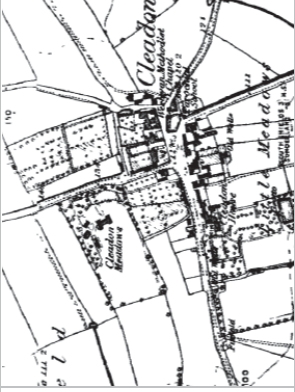
| HER No | Site Name | NGR | Description | Period | Sources | Photo |
|---|---|---|---|---|---|---|
| 2331 | South Shields to Sunderland Road | NZ 3643 6728 | Toll Road from South Shields to Sunderland running through the village. Road opened in 1796, although the route had been in existence at least since the medieval period and is the reason for the existence of the village. Toll houses included Harton Turnpike (SMR 2391). Road was extensively modernized in the 1960s when the layout was widened and rationalized, changing the character of this part of the village quite considerably. | 18th-century | 1st edition Ordnance Survey Map, c.1862, 6-inch scale; Durham, 8<br>1839 Tithe DDR/EA/TTH/1/252<br>CVA landscape and building survey 2013-14 | |

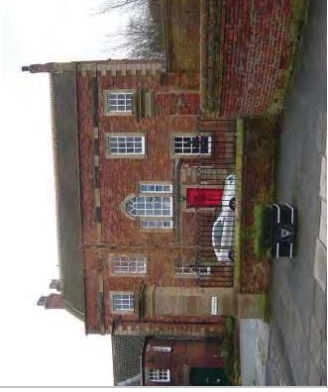
| HER No | Site Name | NGR | Description | Period | Sources | Photo |
|---|---|---|---|---|---|---|
| 8027 | Cleadon, Front Street, Cleadon House | NZ 3707 6173 | Grade II listed house built c.1738 (rainwater heads) for John Dagnia of South Shields, glass manufacturer. Brick with stone dressings; roof of plain tiles.<br><br>Simple block plan. 2 storeys, 5 windows, including a central Venetian staircase window, all with broad moulded glazing bars, raised surrounds and projecting cills. South front to garden has scrolled pediment to central door, moulded architraves to all windows, large oblong fanlights with radial decoration above two side doors; a C19 conservatory encloses the 3 doors.<br><br>Interior: staircase has dado rail and cornice and a wrought-iron balustrade of c.1750 in a rococo design of leaves, seed-pods and curved bars; the front porch has been inserted beneath this; doors to main rooms in hall have corniced picture-panels; fluted pilasters support an elliptical arch to the narrower section of hall opposite the stairs. | 18th-century | Department of National Heritage, List of Buildings of Special architectural or Historic Interest, 3/22<br>1839 Tithe DDR/EA/TTH/1/252<br><b>Grade II* listed building</b> (List No. 1025212)<br>South Tyneside Council, 2007, Cleadon Conservation Area Character Appraisal<br>Maddison, (2013) unpublished report (NEVAG)<br>CVA Building Survey | |

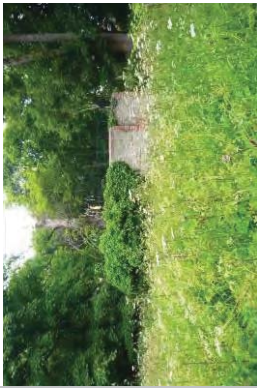
| HER No | Site Name | NGR | Description | Period | Sources | Photo |
|---|---|---|---|---|---|---|
| 12802 | Recreation ground (former garden of Cleadon House) | NZ 3834 6202 | The grounds to Cleadon House were laid out in the picturesque style of the mid to late 18th Century, includes a gothic grotto (HER 8159) that overlooked a lake and terraces. The house had its principal elevation overlooking the grounds, with open views channelled through woodlands to the grotto, lake and pastures beyond. Some vestiges of the grounds survive. Much of the estate was developed in the early 20th Century when the Plantation estate was built. Some large mature trees, principally Chestnut survive from the earlier period. | 18th-century | South Tyneside Council, 2007, Cleadon Conservation Area Character Appraisal, pages 59-60; SOUTH TYNESIDE LOCAL LIST REVIEW 2011, LSHAV152/C Maddison, (2013) unpublished report (NEVAG) 1839 Tithe DDR/EA/TTH/1/252 CVA Building Survey | |

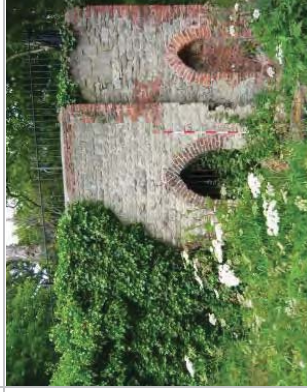
| HER No | Site Name | NGR | Description | Period | Sources | Photo |
|---|---|---|---|---|---|---|
| 8159 (and 12803) | Cleadon House Grotto | NZ 3834 6218 | Garden feature, (formerly in grounds of Cleadon House) Roughly squared coursed limestone rubble with brick dressings. Wall and two returns into and retaining a hill. South elevation has 3 pointed arches flanked by 2 similar niches. A square cover in the ground behind probably replaces a lantern. Interior octagonal with 3 niches in the 3 north sides. There was formerly a lake in front of the grotto. | 18th-century | Department of National Heritage, List of Buildings of Special architectural or Historic Interest, 3/54<br>1839 Tithe DDR/EA/TTH/1/252<br><b>Grade II Listed</b> (List No. 1355067)<br>Maddison, (2013) unpublished report (NEVAG)<br>CVA Building Survey | |

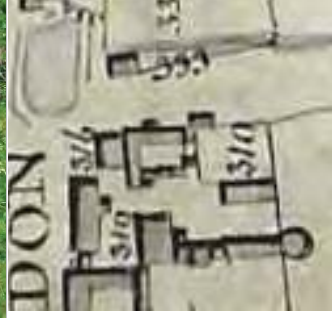
| HER No | Site Name | NGR | Description | Period | Sources | Photo |
|---|---|---|---|---|---|---|
| 12763 | South Farm (French's Farm or Cutler Farm) | NZ 3848 6235 | South Farm stood on the site where Foxton Court now stands. Referred to in the Bishops records as South Farm and also sometimes called French's Farm or Cutler's Farm. Demolished in the 1960s, no surviving remains | 18th-century (possibly medieval in origin) | South Tyneside Council, 2007, Cleadon Conservation Area Character Appraisal, page 8<br>CVA landscape and building survey 2013-14 | |

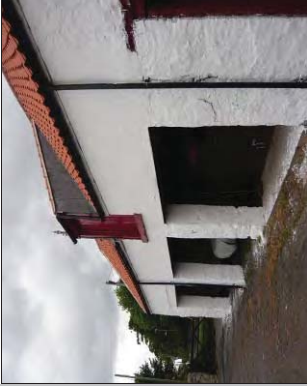
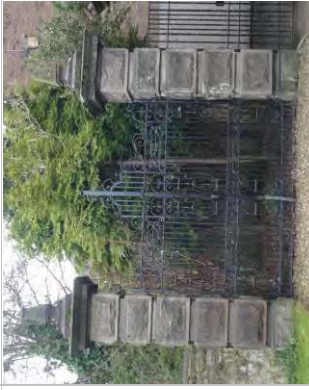
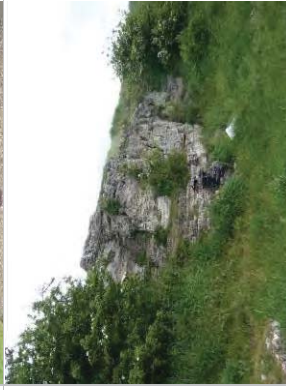
| HER No | Site Name | NGR | Description | Period | Sources | Photo |
|---|---|---|---|---|---|---|
| 8025 | Front Street, gates and piers | NZ 3850 6235 | <p>The extension has an original six-over-six pane timber window. Whitewashed outbuildings surround the farmhouse. The barn along the edge of Cleadon Lane was the original farmhouse, built in the 18th Century. The pitch of its roof suggests that it was previously thatched. The buildings have been modified and extended in response to changing agricultural practices and methods. There is a line of mature trees along the western edge of the farm. West Hall Farm is a remarkably intact group of historic agricultural buildings.</p> <p>Gates: C18, one modern copy. Wrought iron. Gate piers: 3 C18, stone rusticated and vermiculated, with projecting cornices and obelisk finials. Original source of gates is unknown but not from immediate vicinity of Cleadon</p> | 18th-century (relocated) | <p>Council, 2007, Cleadon Conservation Area Character Appraisal, pages 19-20; SOUTH TYNESIDE LOCAL LIST REVIEW 2011, LSHA/149/C Chadwick 'West Farm, Cleadon' (1996), unpublished.</p> <p>Department of National Heritage, List of Buildings of Special architectural or Historic Interest, 3/20</p> <p><b>Grade II Listed Building</b> (List No. 1025210)</p> <p>CVA Building Survey 2014</p> | |

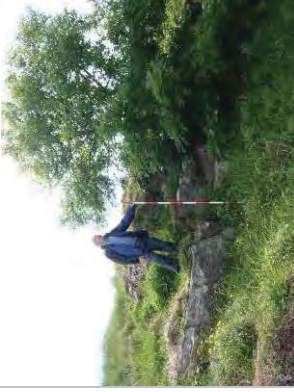
| HER No | Site Name | NGR | Description | Period | Sources | Photo |
|---|---|---|---|---|---|---|
| 2411 | Limestone Quarry | NZ 3878 6400 | Limestone Quarry, first shown on 1839 tithe map and marked as 'old' on the 1st edition OS mapping, so out of use by 1862. | 18th-century? | 1st edition Ordnance Survey Map, c.1862, 25-inch scale, Durham, 4<br>CVA landscape and building survey 2013-14 | |

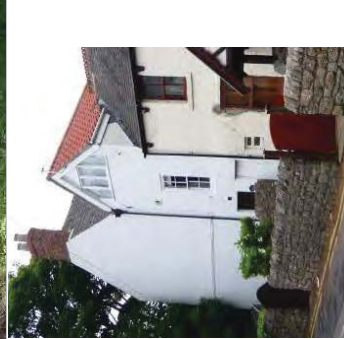
| HER No | Site Name | NGR | Description | Period | Sources | Photo |
|---|---|---|---|---|---|---|
| 12778 | Cleadon, Sunnyside Lane, No. 1 | NZ 3854 6243 | Possibly once a single storey cottage of 17th- or 18th-century date, heightened in the 19th Century to two storeys. The windows are timber sliding sash. The first floor window on the side elevation has been raised. There is a central chimney stack. The open sided timber porch on the front is modern. Building has been recently rendered. | 18th-century? | South Tyneside Council, 2007, Cleadon Conservation Area Character Appraisal, page 30<br>1839 Tithe DDR/EA/TTH/1/252<br>CVA Buildings Survey | |

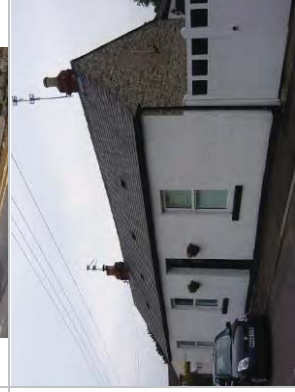
| HER No | Site Name | NGR | Description | Period | Sources | Photo |
|---|---|---|---|---|---|---|
| 12774 | Sunnyside Lane, No. 7 | NZ 3853 6246 | A single storey cottage, possibly 18th-century in date, rendered and painted white. Appears to be a pair of cottages converted into one. The projecting stone cills have been painted black. New windows have been inserted. The roof is Welsh slate, with brick chimney stacks and terracotta pots. Probably associated with the Old Hall garden, which extended to the west. Perhaps a gardener's cottage or workshop. | 18th-century? | South Tyneside Council, 2007, Cleadon Conservation Area Character Appraisal, pages 28-29<br>CVA Building Survey 2014 | |

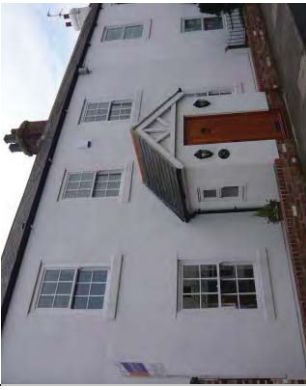
| HER No | Site Name | NGR | Description | Period | Sources | Photo |
|---|---|---|---|---|---|---|
| 12791 | Old Post Office | NZ 3842 6234 | The post office is slotted into a terrace of late 19th-century houses that are rendered. They have replacement windows and timber shutters that clutter the elevations. | 18th-century? | South Tyneside Council, 2007, Cleadon Conservation Area Character Appraisal, page 47 | |

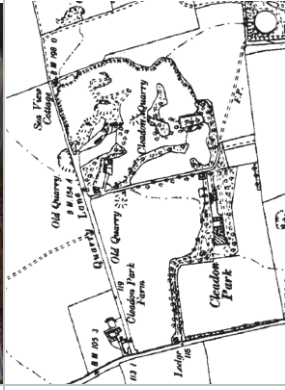
| HER No | Site Name | NGR | Description | Period | Sources | Photo |
|---|---|---|---|---|---|---|
| 2399 | Cleadon Park Limestone Quarry | NZ 3845 6398 | Cleadon Quarry. The precise extents of the site are unclear on the 1st edition OS mapping, which does however show a Lime Kiln within the site. Extensive working shown on first edition map, quarry remained in used until the mid 20th Century. Now a park and housing estate. | 19th-century – founded earlier, perhaps 17th-century. | 1st edition Ordnance Survey Map, c.1862, 6-inch scale, Durham, 4 | |

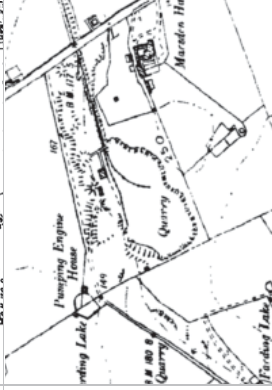
| HER No | Site Name | NGR | Description | Period | Sources | Photo |
|---|---|---|---|---|---|---|
| 2482 (and 2404) | Marsden Old Quarry | NZ 3957 6453 | Quarry at Marsden, which is first shown on the 2nd edition OS map but probably developed from an earlier quarry (HER 2404), shown on the first edition OS. It was served by railway HER 2483. In 2004 during excavation work to strip topsoil from the limestone adjacent to Marsden Old Quarry Local Nature Reserve, a series of what looked like boreholes were found covering an area of approximately 10m x 10m. T | 19th-century | 2nd edition, Ordnance Survey map, 1898, 6-inch scale, Durham, 4, SW | |

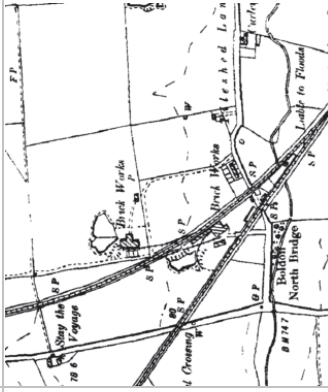
| HER No | Site Name | NGR | Description | Period | Sources | Photo |
|---|---|---|---|---|---|---|
| 2578 | Brick Works | NZ 3635 6215 | Brick Works. This was not shown on the 1st edition OS mapping, so was opened after 1862. 1894, claypit used as a fishpond in 1921. | 19th-century | 2nd edition, Ordnance Survey map, 1898, 6-inch scale, Durham, 8, NW Davison, P.J, 1986. Brickworks of the North East, 122 site 25 | |

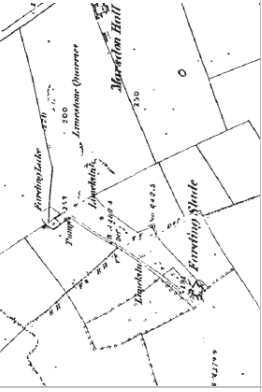
| HER No | Site Name | NGR | Description | Period | Sources | Photo |
|---|---|---|---|---|---|---|
| 2402 | Lime Kiln, Farning Lake Farm | NZ 3921 6440 | Lime Kiln, location unclear on the 1st edition OS mapping, probably lay within a 200m radius of the grid reference. It is not shown on 2nd edition OS mapping, which does mark an Old Quarry near this point and which may have been the disused workings around the kiln. No visible surface evidence surviving. A second kiln is shown to the east of the farm. | 19th-century | 1st edition Ordnance Survey Map, c.1862, 6-inch scale, Durham, 4 CVA landscape and building survey 2013-14 | |

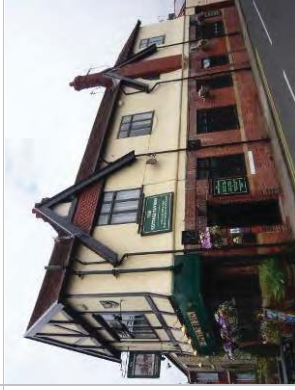
| HER No | Site Name | NGR | Description | Period | Sources | Photo |
|---|---|---|---|---|---|---|
| 12779 | North Street, The Cottage Tavern | NZ 3844 6249 | A 19th-century public house. It was extended at its western end in the later 20th Century. Pitched gables have been added to the south elevation and the first floor rendered, painted white and timber boarding added. | 19th-century | South Tyneside Council, 2007, Cleadon Conservation Area Character Appraisal, page 31 | |

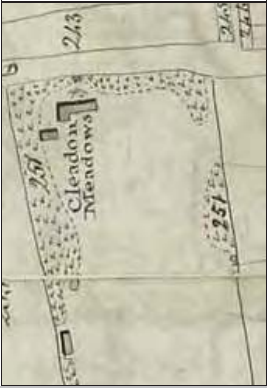
| HER No | Site Name | NGR | Description | Period | Sources | Photo |
|---|---|---|---|---|---|---|
| 12764 | Cleadon Meadows | NZ 3832 6254 | Large mansion built to the design of John Dobson in 1853 on the site of an earlier country house built in the 1820s and shown on the 1839 tithe (see picture). Demolished in the 1960s. The replacement housing estate has the same name. The garden wall survives (HER 12789). | 19th-century | South Tyneside Council, 2007, Cleadon Conservation Area Character Appraisal, page 10<br>1839 Tithe DDR/EA/TTH/1/252<br>CVA Building Survey 2014 | |

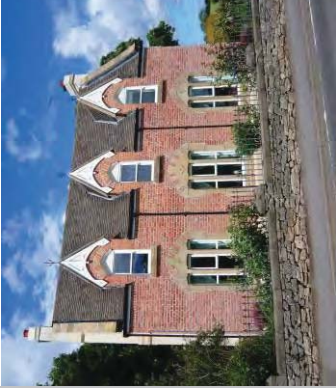
| HER No | Site Name | NGR | Description | Period | Sources | Photo |
|---|---|---|---|---|---|---|
| 12768 | Cleadon Lane, Peacock Lodge | NZ 3900 6225 | An exuberant example of late nineteenth-century date that has been substantially extended. The original building is arts & crafts style. It includes fine detail. Peacock Lodge has a steeply pitched flat tile roof with stone water tabling and chimney stacks with stone shoulders added to both gables. The roof has three dormers with pointed gables. The gables are steeply pitched and are braced by carved timber work that is painted white. There are segmental arches over the windows. The property is bounded by a low stone garden wall. | 19th-century | South Tyneside Council, 2007, Cleadon Conservation Area Character Appraisal, pages 20-21;<br>SOUTH TYNESIDE LOCAL LIST REVIEW 2011, LSHAV150/C<br>CVA Building Survey 2014 | |

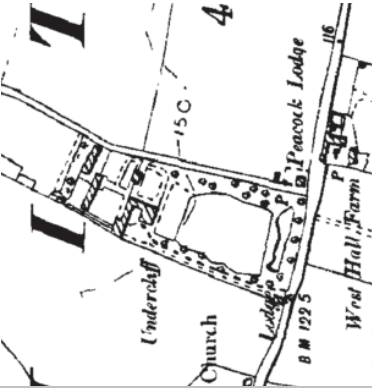
| HER No | Site Name | NGR | Description | Period | Sources | Photo |
|---|---|---|---|---|---|---|
| 8163 | Cleadon Lane, Undercliff | NZ 3897 6243 | House, now 3 separate dwellings. Built circa 1853 for the Allison family. Brick with sandstone dressings; Welsh slate roof. 2 storeys; 3 bays on west front defined by 4 Tuscan giant pilasters with stone plinths and capitals. Hipped roof, square brick chimneys with stone bands and cornices. Plain 2-storey, 4-bay wing on east has 2-storey, 2-bay return forming a courtyard with a range consisting of a passage, a house of 2 low storeys, a cottage, a carriage entrance and a coach house. A curved brick wall extending from the north-west corner of the house to the courtyard entrance has, on the courtyard side, a brick mounting block with 3 stone steps. | 19th-century | Department of National Heritage, List of Buildings of Special architectural or Historic Interest, 3/7<br><b>Grade II Listed Building</b> (List No: 1355077)<br>CVA Building Survey 2014 | |

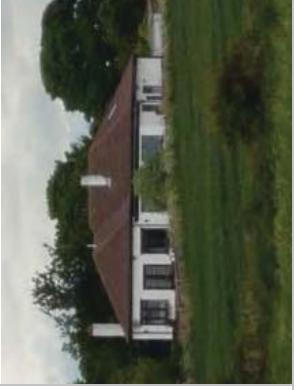
| HER No | Site Name | NGR | Description | Period | Sources | Photo |
|---|---|---|---|---|---|---|
| 12769 | Cleadon Lane,<br>Undercliff Lodge | NZ 3886 6228 | Gate lodge to Undercliff (HER 8163). It has been extended along its western elevation with the addition of a flat roofed building in the 1970s, which is painted white. The extension is inappropriate. | 19th-century | South Tyneside Council, 2007, Cleadon Conservation Area Character Appraisal, pages 22-23 | |

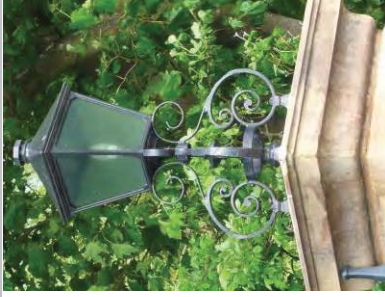
| HER No | Site Name | NGR | Description | Period | Sources | Photo |
|---|---|---|---|---|---|---|
| 9610 | Cleadon Lane,<br>Undercliff,<br>boundary wall | NZ 3891 6226 | See above. | 19th-century | Tyne and Wear Specialist Conservation Team, March 1992, Other Buildings of Acknowledged Architectural Quality or Historic Significance (South Tyneside UDP Appendix ENV (B))<br>CVA Building Survey 2014 | |

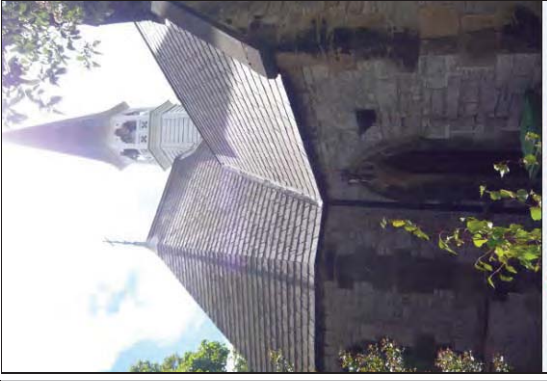
| HER No | Site Name | NGR | Description | Period | Sources | Photo |
|---|---|---|---|---|---|---|
| 8047 | Cleadon Lane, Church of All Saints | NZ 3858 6235 | Parish church. 1869 by R J Johnson, south aisle 1907. Snecked limestone rubble with sandstone ashlar quoins and dressings, high-pitched roofs of Welsh slate with stone coping to nave and aisle, in Early English style. Nave with south aisle and south porch, chancel with 3-sided apse, north transept. Transept has a 2-light window in the gable and an east door with flower stops to a drip-mould. Roof has stone cross finial at west, iron at east; above the chancel a hexagonal timber bellcote with Welsh slate spirelet and iron finial; chimney at the transept gable.<br>Interior: south arcade of 2 wide bays, paintings of Garden of Gethsemane by J Eadie Read of Newcastle c.1914 in spandrels; apse paintings of Christ on the Cross and Christ in Majesty by Michael Hoare of Folkestone in 1967; 2-light west Window, war memorial by L C Evetts of Newcastle in 1948. | 19th-century | Department of National Heritage, List of Buildings of Special architectural or Historic Interest, 3/8 Grade II Listed Building (List No: 1025247)<br>Chadwick, M (1994) unpublished report<br>CVA Building Survey 2014 | |

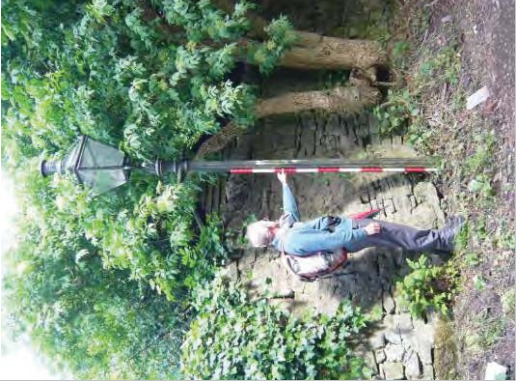
| HER No | Site Name | NGR | Description | Period | Sources | Photo |
|---|---|---|---|---|---|---|
| 8114, 8117 | Cleadon, West Park Road, No. 8 and No. 4 gas lamps | NZ 3813 6621<br>NZ 3812 6223 | Gas street lamp. Late C19. Cast iron fluted standard, supporting square glazed lap with circular ventilator cap. | 19th-century | Department of National Heritage, List of Buildings of Special architectural or Historic Interest, 103<br>CVA Building Survey 2014 | |

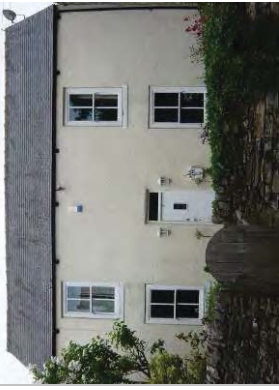
| HER No | Site Name | NGR | Description | Period | Sources | Photo |
|---|---|---|---|---|---|---|
| 12776 | Sunnyside Lane, No. 3 | NZ 3854 6244 | A two-storey house set back from its neighbours. Probably 19th-century incorporating remnants of earlier structures. It was once attached to a range of structures around a farmyard. A simple double fronted traditional two-up two-down property. It is rendered white. The lower cills are stone. The chimney stacks are located at eaves height creating a flat ridge line. The windows are replacements. A drive between Nos. 1 and 3 leads into the former farmyard. | 19th-century | South Tyneside Council, 2007, Cleadon Conservation Area Character Appraisal, page 30 | |

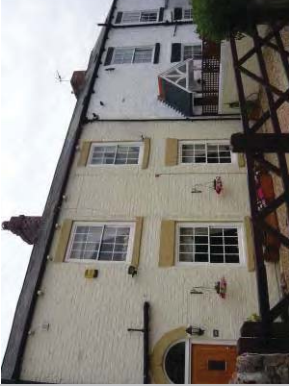
| HER No | Site Name | NGR | Description | Period | Sources | Photo |
|---|---|---|---|---|---|---|
| 12792 (inc. 12767) | Front Street, Nos. 18 to 22 | NZ 3842 6232 | Nursery Lane once led to extensive areas of glass houses behind Cleadon Tower. Today it still contains an extremely attractive terrace of houses. Built in 1860, the houses are rendered. Some retain their original six-over-six windows and doors. Sections of stone boundary wall survive. The houses face onto an unattractive garage court. | 19th-century | South Tyneside Council, 2007, Cleadon Conservation Area Character Appraisal, page 47<br>CVA Building Survey 2014 | |

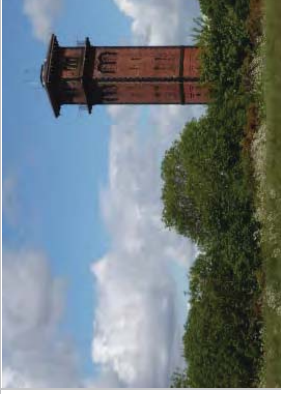
| HER No | Site Name | NGR | Description | Period | Sources | Photo |
|---|---|---|---|---|---|---|
| 2480 | Cleadon Pumping Station | NZ38696357 | Cleadon Pumping Station (Sunderland and South Shields W.W.) Cleadon Water Pumping Station NZ 389632(A). Built by Thomas Hawksley, the ornamental grounds contain a neo-Italianate engine house, boiler house and cottages all dominated by a camponile chimney. Built 1860, originally steam powered with 2 cornish engines and 3 cornish boilers, the station was electrified c1930. The complex forms part of a Conservation Area and the buildings are listed. | 19th-century | 2nd edition, Ordnance Survey map, 1898, 6-inch scale, Durham, 4, South Tyneside Council, 2007, Cleadon Hills Conservation Area Character Appraisal<br><b>Grade II* Listed Building (LN 1232322)</b> | |

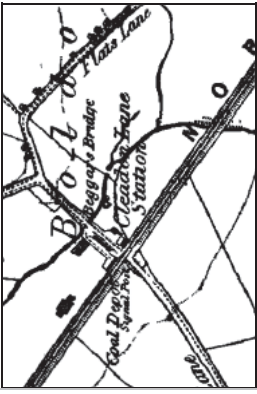
| HER No | Site Name | NGR | Description | Period | Sources | Photo |
|---|---|---|---|---|---|---|
| 2289 | Branding Junction Railway, Sunderland Branch (later NER – HER 1186) | NZ 2966 6215 | The North Eastern Railway, Sunderland Branch was originally the Brandling Junction Railway from Gateshead to Monkwearmouth, opened in 1839. The line passed through an unbroken tract of open countryside, except at Fulwell where a cutting had to be created through the magnesian limestone, nearly a mile long and up to 29 feet deep. Its southern terminus was Monkwearmouth Station (HER 2751). Only the remains of the embankment walls remain in-situ. The station now forms part of the Metro line. | 19th-century | 1st edition Ordnance Survey Map, c.1862, 6-inch scale, Durham, 3<br>N.T. Sinclair, & I.S. Carr, 1990, Railways of South Shields, p.6;<br>W.W. Tomlinson, 1914, The North Eastern Railway - Its Rise and Development, p 327<br>CVA Landscape Survey 2013 | |

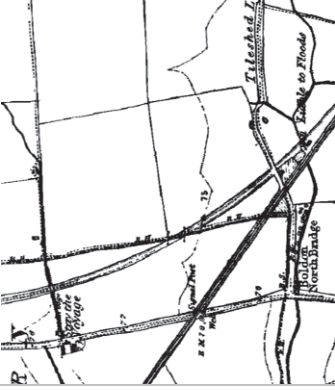
| HER No | Site Name | NGR | Description | Period | Sources | Photo |
|---|---|---|---|---|---|---|
| 2332 | Branding Junction Railway, Biddick Branch | NZ 3602 6365 | Railway or Wagonway. The southern end is the junction with the North Eastern Railway, Sunderland Branch (SMR 2289). This was part of the Biddick Branch of the Brandling Junction Railway, which was opened in 1839 and closed in 1840. The northern section was still in use as a railway (SMR 2395) related to Harton Colliery. The line was completely reopened as the North Eastern Railway Harton Branch in 1867, its northern end having been remodelled, see SMR 2550. | 19th-century | 1st edition Ordnance Survey Map, c.1862, 6-inch scale, Durham, 8<br>N.T. Sinclair, & I.S. Carr, 1990, Railways of South Shields, p.6 | |

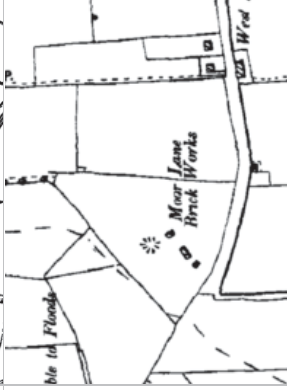
| HER No | Site Name | NGR | Description | Period | Sources | Photo |
|---|---|---|---|---|---|---|
| 2581 | Moor Lane Brick Works | NZ 3816 6145 | Moor Lane Brick Works. Works not shown on the 1st edition OS map so were opened after 1862. Expand considerably in the early 19th Century, possibly serving construction of the Plantation estate.<br>No surviving evidence – now part of Broadlands estate | 19th-century | 2nd edition, Ordnance Survey map, 1898, 6-inch scale, Durham, 8, NW<br>CVA landscape and building survey 2013-14<br>Davison, P J, 1986. Brickworks of the North East, 122 site 27. | |

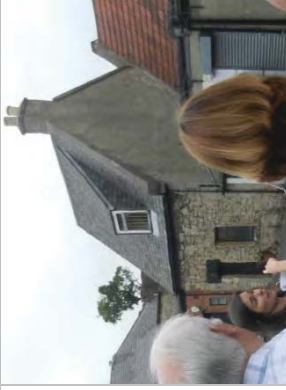
| HER No | Site Name | NGR | Description | Period | Sources | Photo |
|---|---|---|---|---|---|---|
| 12793 (inc. 12766) | Front Street, workshop | NZ 3833 6230 | The backland area annexed to Cleadon House (HER 8027) comprises a small but extremely interesting collection of buildings. This includes a small irregular coursed limestone workshop with a high roof pitch (HER 12766). There is a red brick back wall of a former estate building with an attractive late 19th-century box bay at first floor level. The yard gives an interesting glimpse of the working buildings of the old village. It is of considerable architectural and historic merit. | 19th-century (possibly with some 18th-century elements) | South Tyneside Council, 2007, Cleadon Conservation Area Character Appraisal<br>1839 Tithe DDR/EA/TTH/1/252<br>CVA Buildings Survey 2014 | |

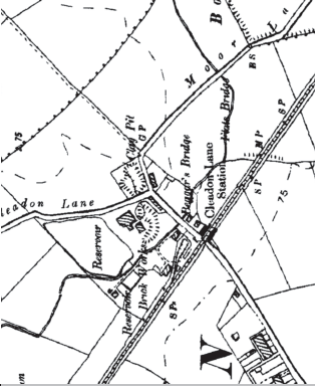
| HER No | Site Name | NGR | Description | Period | Sources | Photo |
|---|---|---|---|---|---|---|
| 2577 | Cleadon Junction<br>Brick Works | NZ 3637 6230 | Brick Works. This was not shown on the 1st edition OS mapping, so was opened after 1862. 1894-1938 | 20th-century | 2nd edition, Ordnance Survey map, 1898, 6-inch scale, Durham, 8, NW Davison, P J, 1986. Brickworks of the North East, 122 site 24. | |

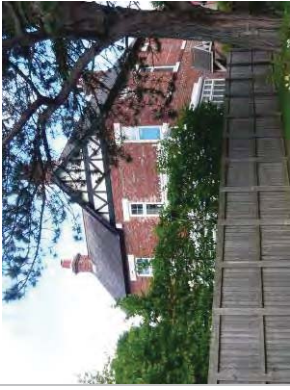
| HER No | Site Name | NGR | Description | Period | Sources | Photo |
|---|---|---|---|---|---|---|
| 12801 | Cleadon Plantation | NZ 380 620 | Cleadon Plantation, a landscaped estate, was built over Cleadon Moor and Little Moor to the west of the historic core from the start of the 20th Century. It lies over an undulation of Cleadon Hills falling gently from the north east to south west. The estate comprised a collection of large houses in generous gardens using well established tree and hedge lines to create a sense of enclosure and privacy. The quality of pre-First World War housing stock is outstanding. Houses were approached by drives that cut across the gardens and were south facing to take advantage of views over the sloping gardens. Some houses had short garden terraces. This echoes the estates like Regent's Park in | 20th-century | South Tyneside Council, 2007, Cleadon Conservation Area Character Appraisal, pages 55-86<br>CVA Buildings Survey 2014 | |

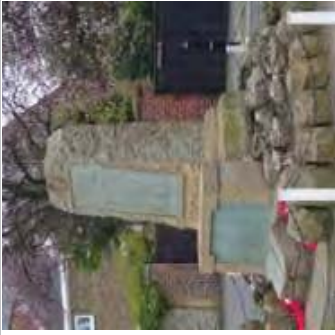
| HER No | Site Name | NGR | Description | Period | Sources | Photo |
|---|---|---|---|---|---|---|
| 10964<br>(same as 11198) | Front Street, War Memorial (WW1 and WW2) | NZ 384 623 | London that were built in the 1830s and 40s and the later Garden Suburb movement.<br>First and Second World War Memorial. Unveiled November 1920 by Col. G. Pollard of Seaton Delaval. A pink rough hewn slab with a laurel wreath at the top and the names of the dead and those who served in World War One on a Welsh green slate panel. There is a cross on the step below. Located in a rockery. The sculptor was Thomas Curry of South Shields. There is a plaque on the right side "E. Smyth, Sunderland". | 20th-century | Ian Ayris, Peter Jubb, Steve Palmer and Paul Usherwood, 1996, A Guide to the Public Monuments and Sculpture of Tyne and Wear, p 65; North East War Memorials Project Ref. C79.01 ( <a href="http://www.newmp.org.uk">www.newmp.org.uk</a> ); Newcastle Weekly Chronicle 20 November 1920; South Shields in Old Picture Postcards | |

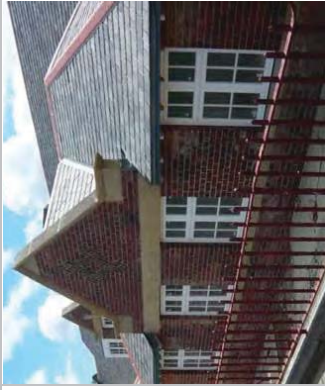
| HER No | Site Name | NGR | Description | Period | Sources | Photo |
|---|---|---|---|---|---|---|
| 12771 | Cleadon Lane, Senior School (later Infant School) | NZ 3061 6233 | Cleadon School was built in 1907. It is brick, with a Welsh slate roof with red clay ridge tiles. There are gabled wings projecting from the front elevation. The school was originally divided into a boys and girls school. The water tabling, lintels and cills are stone. Above the windows are key stones with brick on edge detail. The rainwater goods are cast iron. There is a brick boundary wall with stone coping, with a steel fence on top. The school is no longer in use and has permission granted for conversion to residential. | 20th-century | South Tyneside Council, 2007, Cleadon Conservation Area Character Appraisal, pages 24-25; SOUTH TYNESIDE LOCAL LIST REVIEW 2011, LSHA/159/C 'Cleadon's Schools', Kathleen Robinson (2014), unpublished report | |

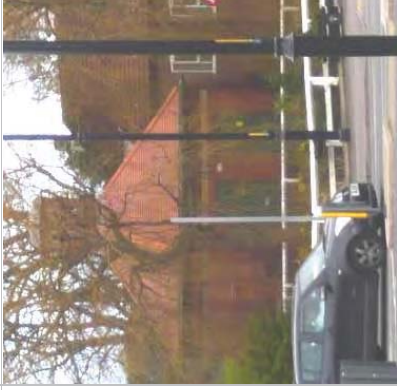
| HER No | Site Name | NGR | Description | Period | Sources | Photo |
|---|---|---|---|---|---|---|
| 12782 | Front Street, electricity substation | NZ 3855 6237 | bay sits over the porch. A full height timber box bay and a ground floor bay, with original windows and heavy cornices are attached to the south elevation. There are mature landscaped gardens.<br>A pre-First World War electricity substation. Brick built with a rosemary tile roof. It is surmounted by a square tower with an open ventilation lantern with a lead ogee shaped roof. It has projecting brick cills and a dog-tooth brick cornice. | 20th-century | Character Appraisal, page 38;<br>SOUTH TYNESIDE LOCAL LIST REVIEW 2011, LSHA/161/C<br><br>South Tyneside Council, 2007, Cleadon Conservation Area Character Appraisal, page 34<br>CVA Buildings Survey 2014 | |

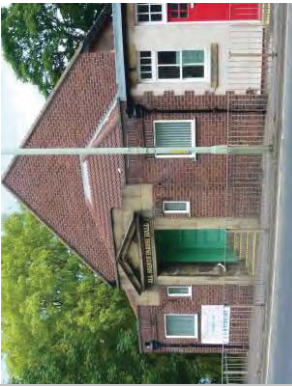
| HER No | Site Name | NGR | Description | Period | Sources | Photo |
|---|---|---|---|---|---|---|
| 12783 | Cleadon, All Saints Church, church hall (location of Parochial School) | NZ 3854 6236 | Inter-war church hall. Brick with shallow buttress supports on the north and south elevations. Rendered and incised to look like masonry. Original windows. Slate roof. Little ornamentation except the front porch with a concrete doorway with simple triangular pediment with 'ALL SAINTS CHURCH HALL' painted across it. The church hall is situated on the site of the old Parochial School, which served as the village hall after the school next door was built in 1903 | 20th-century | South Tyneside Council, 2007, Cleadon Conservation Area Character Appraisal, page 38;<br>SOUTH TYNESIDE LOCAL LIST REVIEW 2011, LSHA/160/C<br>CVA Buildings Survey 2014 | |

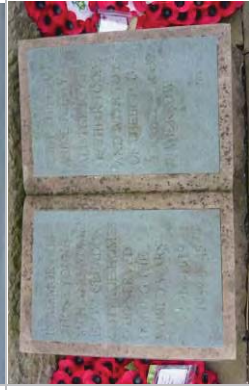
| HER No | Site Name | NGR | Description | Period | Sources | Photo |
|---|---|---|---|---|---|---|
| 11199 | Front Street, War Memorial (Cleadon Cottage Homes) | NZ 3844 6236 | Stone book with pages open on steps in front of an altar (HER 11198). Inscription of a pink panel: "IN MEMORY OF THOSE YOUNG MEN AND WOMEN FROM CLEADON COTTAGE HOMES WHO SERVED DURING THE WORLD WARS 1914-1919 1939-1945". | 20th-century | North East War Memorials Project Ref. C79.06 ( <a href="http://www.newmp.org.uk">www.newmp.org.uk</a> );<br>SOUTH TYNESIDE LOCAL LIST REVIEW 2011, LSHA/156/C | |

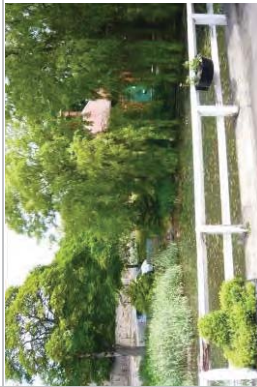
| HER No | Site Name | NGR | Description | Period | Sources | Photo |
|---|---|---|---|---|---|---|
| 12781 | Village pond | NZ 3853 6238 | The heart of the village and one of two ponds that used to serve Cleadon; a second header pond being located on Sunnyside Lane. The current pond was reduced in size when the road was widened in the 1960s | Medieval | South Tyneside Council, 2007, Cleadon Conservation Area Character Appraisal, pages 33-4;<br>SOUTH TYNESIDE LOCAL LIST REVIEW 2011, LSHA/151/C<br>1839 Tithe DDR/EA/TTH/1/252<br>CVA Landscape Survey 2013-14 | |

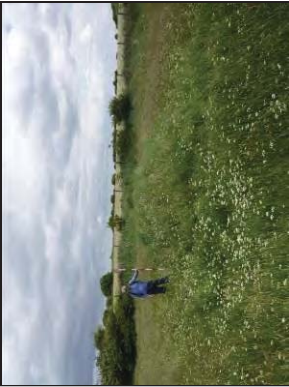
| HER No | Site Name | NGR | Description | Period | Sources | Photo |
|---|---|---|---|---|---|---|
| 975 | Cleadon Hill, army trenches | NZ 389 631 | On Cleadon Hill, west and south-west of the windmill, there are short, slightly curved, stretches of ditch with the upcast piled on one side. By oral tradition these were said to be army trenches, date of digging unknown. Some of the features in this area are definitely associated with the pre-1914 golf course but at least 4 and perhaps 5 could be WWI trenches, though not the classic zigzag networks. These notably face each other and are orientated east to west. Range from 28 to 12m long and are approx 2m wide with a raised bank on one side and shallow recess on the other. Majority of features probably relate to pre-war golf course extension. | WWI | Pers. Comm. P.R.M. Harbottle, 1993, Cleadon Hill trenches - Historic Environment Record<br>CVA landscape and building survey 2013-14 | |

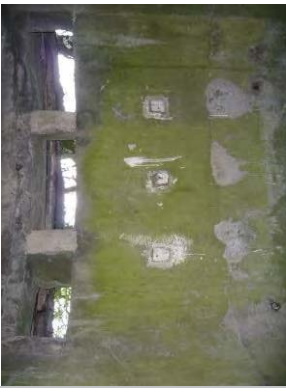
| HER No | Site Name | NGR | Description | Period | Sources | Photo |
|---|---|---|---|---|---|---|
| 4652 | Cleadon Hills, Pillbox | NZ 3913 6241 | Potential WWI pillbox constructed of concrete and brick and partially hidden in the hedgerow. | WWI? | Defence of Britain Project, 2002, Defence of Britain Database, S0002914; SOUTH TYNESIDE LOCAL LIST REVIEW 2011, LSHAV157/C<br>CVA landscape and building survey 2013-14<br>Roger Thomas pers com | |

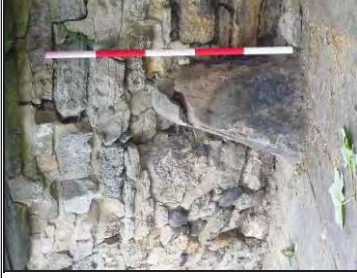
| Survey No. | Site Name | NGR | Description | Period | Sources | Photo |
|---|---|---|---|---|---|---|
| CS1 | Guard stone | NZ 38540 62422 | Guard stone at the junction of Front Street and Sunnyside Lane, adjacent to Burdon Farm. These were positioned to protect walls from damage from carts or agricultural equipment. Possibly contemporary with the wall and may be 18th-century. Top of the stone is damaged. Consideration should be given to repairing this to prevent further decline. | 18th-century? | CVA Building Survey 2014 | |

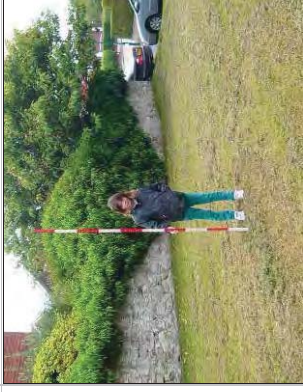
| CS2 | Former pond on Sunnyside Lane | NZ 38541 62486 | Second pond to the north of the village pond and east of Burdon Farm. Shown in 1839 tithe and maybe medieval in origin. Feature was infilled in the early 20th Century and now only survives as a shallow depression in the grass close to the junction of North Road and Sunnyside Lane | Medieval? | 1st edition Ordnance Survey Map, c.1862, 6-inch scale; CVA landscape and building survey 2013-14 | |

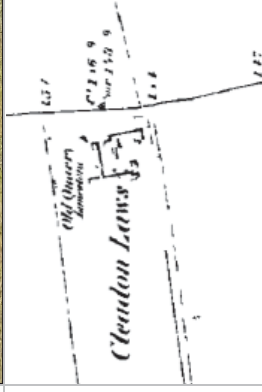
| CS3 | Cleadon Laws | NZ 3793 6343 | Cleadon Laws – place name might suggest a former prehistoric barrow site, although no surviving evidence above ground. Later a post-enclosure farmstead dating to the 17th Century, shown on the 1839 tithe map. A small limestone quarry is recorded on the first edition OS map (1862), already marked as 'old'. | 17th century but place name could indicate prehistoric activity | 1st edition Ordnance Survey Map, c.1862, 6-inch scale; 1839 Tithe DDR/EA/TTH/1/252 CVA landscape and building survey 2013-14 | |

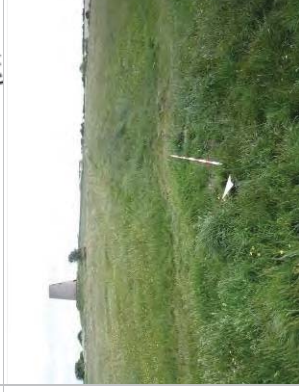
| CS4 | Cleadon Mill boundary wall | NZ 3890 6312 | Remains of boundary wall running west of Cleadon Mill and shown on the first edition OS map, approximately 200m long and 1.25m wide, constructed of local limestone although only survives as grassed over footings | 17th – 18th C | 1st edition Ordnance Survey Map, c.1862, 6-inch scale CVA landscape and building survey 2013-14 | |

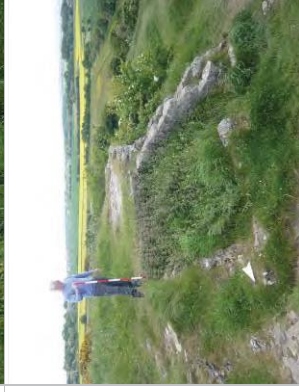
| CS5 | Structure in old quarry (in 2414) | NZ 3885 6301 | Remains of a small stone built building or structure on the western edge of the quarry. Measure approx. 2.25m across with an 'entrance' at the NW end. Rear wall is cut into the hill, SW wall of local limestone. Feature approx. 80cm deep. Might be a small quarryman's shelter or possibly a crane base of some sort. | 17th – 18th C? | Does not appear on any of the historic OS maps. Not shown on the first edition OS 25-inch map. CVA landscape and building survey 2013-14 | |

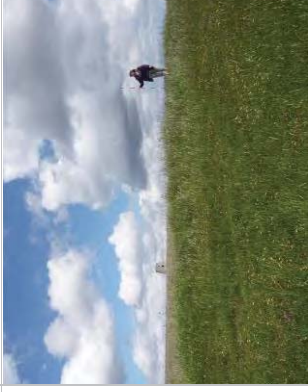
| CS6 | Remains of pre-war golf course | NZ 3896 6294 | Linear banks and a shallow circular depression with surrounding banks, associated with the pre-1914 golf course. | 20th-century | Aerial photographs CPE-UK-2175 CVA landscape and building survey 2013-14 | |

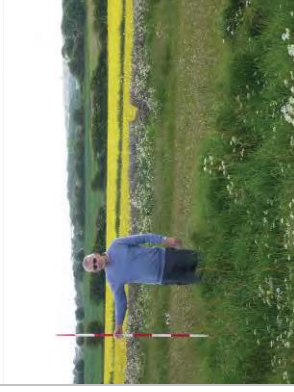
| CS7 | Earthworks adjacent to Cleadon Mill | NZ 3890 6321 | Oval enclosure, measuring 25m east to west and 13m north to south. Central depression with raised collar with stonework under the surface, suggesting a walled enclosure. Shape and proximity to Cleadon Mill Farm would suggest a pond but interior was not boggy and feature is not annotated as containing water on the 25-inch first edition OS map. Possibly a paddock or sheep stell. | 17th – 18th C? | 1st edition Ordnance Survey Map, c.1862, 6-inch scale, CVA landscape and building survey 2013-14 | |

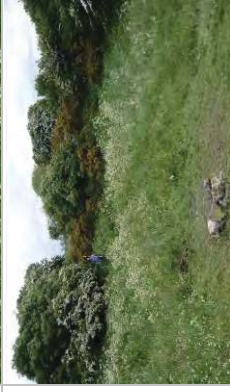
| CS8 | Limestone quarry | NZ 3906 6307 | Limestone Quarry, marked as Old on the 1st edition OS mapping so was out of use by 1862. Large amount of rubble found in the undergrowth, which would suggest a small structure, now demolished | 17th – 18th century? | 1st edition Ordnance Survey Map, c.1862, 6-inch scale, Durham, 4 | |

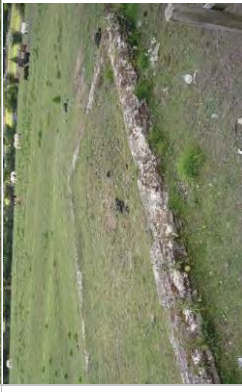
| CS9 | WWI officers barracks | NZ 3865 6236 | Footing of barrack block occupied by British and Canadian officers during WWII and associated with the searchlight battery. Footings survive well and can be clearly seen, building measures 20m x 30m, aligned along road. | WWII | Information from Maurice Chadwick CVA landscape and building survey 2013-14 | |

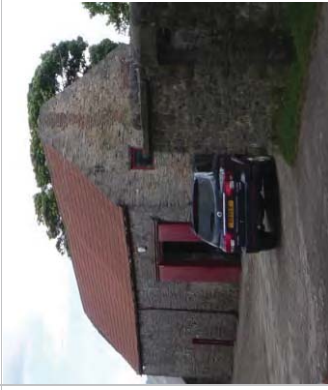
| CS10 | Cleadon Hills Farm | NZ 3922 6336 | Cleadon Hills Farm. Post-enclosure farmstead, although may have medieval origins. Current farmhouse is modern but evidence of an earlier structure forming part of the existing barn. This may be early 18th-century in date. Would warrant further research and recording, subject to tenants approval and permission. | 17-18th century | 1st edition Ordnance Survey Map, c.1862, 6-inch scale; Durham, 4 1839 Tithe DDR/EA/TTH/1/252 CVA Survey 2013-14 | |

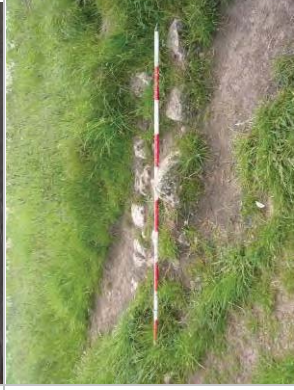
| CS11 | Fragment of wall footings associated with Farding Lake farm | NZ 3929 6440<br>NZ 3946 6432<br>NZ 3934 6427 | Wall footings associated with old field boundaries belonging to Farding Lake Farm. Footings are visible running across footpath where ground has eroded away, although walls have all been demolished and are no longer visible at surface. | 17-18th century | 1st edition Ordnance Survey Map, c.1862, 6-inch scale, Durham, 4 CVA landscape and building survey 2013-14 | |

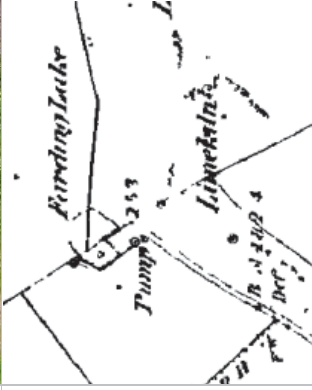
| CS12 | Farding Lake pump | NZ 3922 6439 | Pump adjacent to Farding Lake and first shown on the first edition OS (1862). The 1919 third edition map shows this as a 'windpump' presumably for supplying the farm with water. The second (and third) edition map also shows a 'Pumping Engine House' located slightly further north at the tip of the lake. This may have been providing water to Marsden Village. There is no surviving, above ground, evidence today. | 18th-century? | 1st edition Ordnance Survey Map, c.1862, 6-inch scale, Durham, 4 CVA landscape and building survey 2013-14 | |

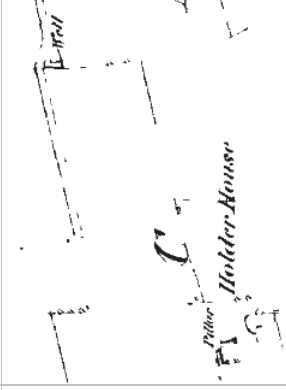
| CS13 | Hodder Farm | NZ 3726 6307<br>NZ 37596 63304<br>(well) | Farm shown on 1st edition Ordnance Survey Map and continuing through into the late 20th Century. Map shows annotation 'pillar' but unclear what this is. There is a well shown to the north east. Appears to be post-enclosure farmstead. No longer standing. | 18th-century? | 1st edition Ordnance Survey Map, c.1862, 6-inch scale, Durham, 4<br>CVA landscape and building survey 2013-14 | |
