## APPENDIX 1: SITE INVENTORY

### Tyne and Wear HER Entries

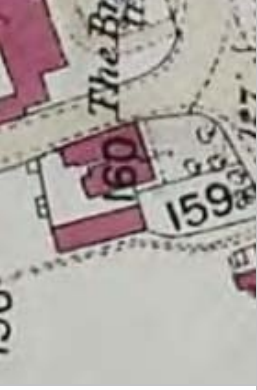
| CS15 | The Matthew House (the Old Britannia Inn) | NZ 3842 62411 | Building formerly standing where the Britannia Inn now stands. Fireplace in the Britannia originally came from this building, which is believed to be contemporary with the 17th Century phase of Cleadon Tower and belonged to the Matthew Family, one of the foremost families in the village, with considerable amounts of land. Demolished when the pub was built 1897. Part may have been incorporated into the later structure. | 17th-century | 1st edition Ordnance Survey Map, c.1862, 6-inch scale; Durham, 4<br>1839 Tithe DDR/EA/TTH/1/252<br>CVA Landscape/Buildings Survey | |

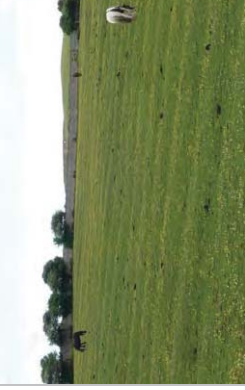
| CS16 | Ridge and Furrow at Cleadon Hills Farm | NZ 3934 6338 | Part of HER 11686. A well-preserved block of ridge and furrow to the north of Cleadon Hills Farm (Well Close Field). Narrow rigg measuring approx 2-3m across with gentle curve. Divided into furlongs with headlands still clearly visible. No walls of hedges. Possibly at least one furlong of broad rigg | Medieval to 18th-century | EH Aerial CPE-UK-2175.TIF<br>CVA Landscape/Buildings Survey | |

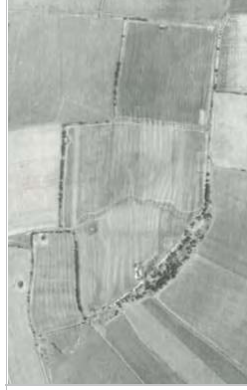
| CS17 | Former ridge and furrow on Cleadon Hills | NZ 3934 6293 | Part of HER 11686. A cluster of ridge and furrow visible on the Cleadon Hills to the south of Cleadon Hills Farm. Visible on post-war aerial photographs but now ploughed out, although line of S-curve is preserved in boundary walls. Looks to be broad riggs. | Medieval | EH Aerial CPE-UK-2175.TIF<br>CVA Landscape/Buildings Survey | |

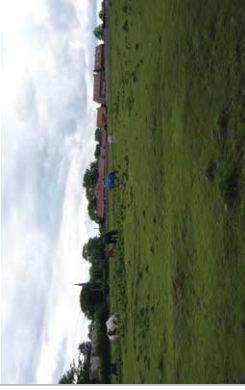
| CS18 | Ridge and Furrow at East Farm | NZ 3866 6245 | Part of HER 973. Two blocks of ridge and furrow surviving to the east of East Farm. Broad riggs measuring 4-5 m across and running NW to SE. Headlands visible. | Medieval | EH Aerial CPE-UK-2175.TIF<br>CVA Landscape/Buildings Survey | |

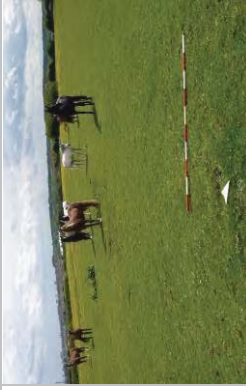
| CS19 | West Farm Ridge and Furrow | NZ 3929 6197 | Well-preserved ridge and furrow clearly visible to the rear of West Farm. Broad riggs, measuring 4m across with reverse-S visible and headlands visible. | Medieval | EH Aerial CPE-UK-2175.TIF<br>CVA Landscape/Buildings Survey | |

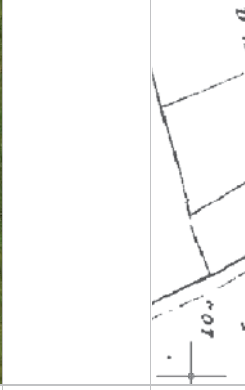
| CS20 | Cleadon Park Farm | NZ 3821 6377 | Post-enclosure farmstead probably founded in the 17th Century. Later developed into Cleadon Park House (HER 7792) | 17th-century | 1st edition Ordnance Survey Map, c.1862, 6-inch scale; Durham, 4<br>1839 Tithe DDR/EA/TTH/1/252<br>CVA landscape and building survey 2013-14 | |

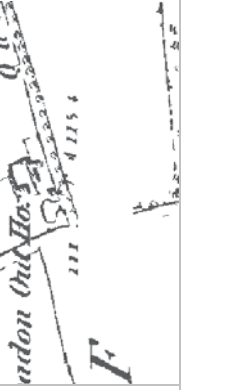
| CS21 | Cleadon Out House | NZ 37975 6397 | 18th-century enclosure farmstead, first appearing on the 1839 tithe and later on the 1st edition 6-inch OS map. Courtyard farmstead to the north of Cleadon Park farm | 18th-century? | 1st edition Ordnance Survey Map, c.1862, 6-inch scale; Durham, 4<br>1839 Tithe DDR/EA/TTH/1/252<br>CVA landscape and building survey 2013-14 | |

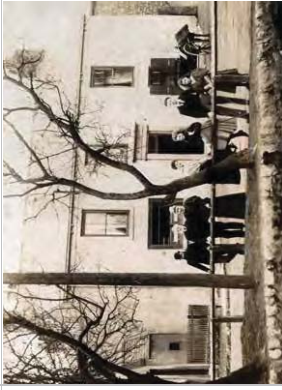
| CS22 | The Ship Inn | NZ 3850 6236 | Formerly located at the junction of the Sunderland Road and Front Street this was one of two coaching inns in Cleadon and probably dated to the 18th Century, if not earlier. Building was demolished in the early 1960s when the road was widened. | 18th-century | 1st edition Ordnance Survey Map, c.1862, 6-inch scale; Durham, 4 1839 Tithes DDR/EA/TTH/1/252 CVA landscape and building survey 2013-14 | |

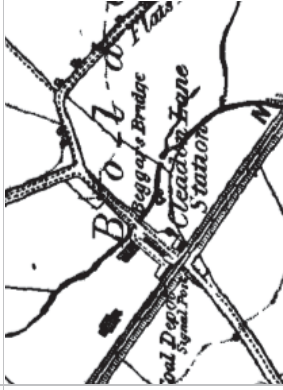
| CS24 | Cleadon Lane Station | NZ 3717 6154 | Station first associated with the Brandling Railway and later taken over by the NER and renamed East Boldon Station. Today forms part of the Metro line but little of the original fabric of the station survives. | 19th-century | 1st edition Ordnance Survey Map, c.1862, 6-inch scale; Durham, 4 CVA landscape and building survey 2013-14 | |

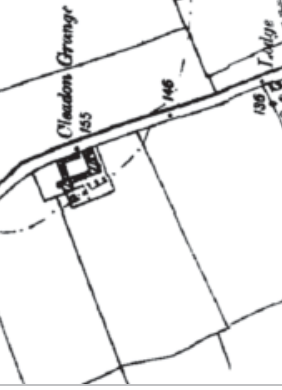
| CS26 | Cleadon Grange | NZ 38274 62851 | Cleadon Grange, property associated with North Farm, both formed in the early 19th Century and lying to the north of the main village. The farm is arranged around a central courtyard with the main farmhouse, the Grange, forming the southern side of the complex. In the late 19th Century it was the home of George Pollard and his family. George laid the foundation stone for the new village school in 1902, and he and his wife erected three stained-glass windows in the church to commemorate the safe return of their son (Major George Pollard) from World War I. | 19th-century | | |

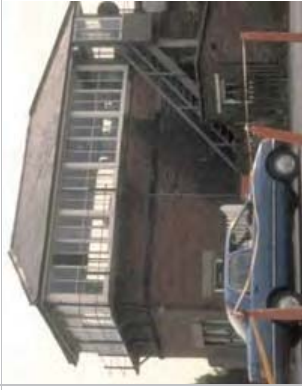
| CS27 | Tilsheds signal box | NZ 3641 6211 | Signal box was first opened in 1875 to control the crossover and siding on the Tyne Dock branch of NER railway, which separated from the Sunderland to Newcastle main line a few metres south at Cleadon Junction. In addition, the signalman monitored the level crossing, opening and closing the wheel-worked gates to let people and carriages along Tilsheds Lane. | 19th-century | 2nd edition Ordnance Survey Map, c.1898, 6-inch scale; Durham, 4 CVA landscape and building survey 2013-14 | |

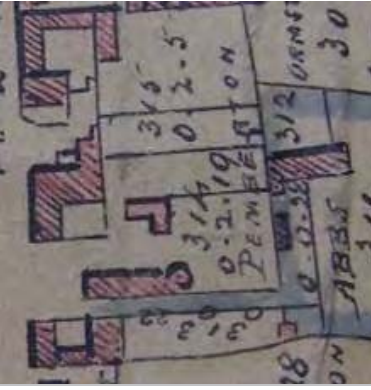
| CS28 | Bainbridge Farm | NZ 38450 62320 | Farm shown on 1839 tithe, farmed by George Bainbridge on land belonging to Richard Pemberton. Originally located on the east side of Nursery Lane, formerly known as Dog-kennel Lane. One of four farms in the village in the 19th Century and potentially medieval in origin. | Medieval? | 1st edition Ordnance Survey Map, c.1862, 6-inch scale; Durham, 4 1839 Tithe DDR/EA/TTH/1/252 CVA landscape and building survey 2013-14 | |

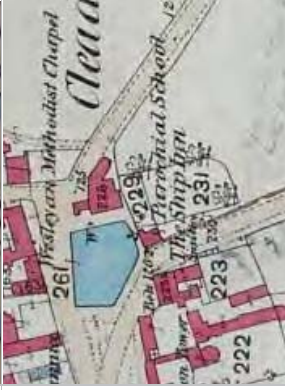
| CS29 | The Cluster | NZ 3856 6238 | Group of cottages that formerly stood to the east of the village pond, clustered around the wellhead. Demolished in the 20th Century. | 18th-century? | 1st edition Ordnance Survey Map, c.1862, 25-inch scale; Durham, 4 1839 Tithe DDR/EA/TTH/1/252 CVA landscape and building survey 2013-14 | |

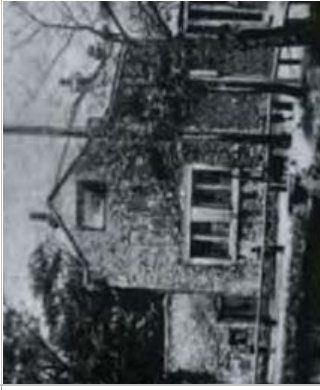
| CS30 | Parochial School | NZ 3854 6236 | The Cleadon Parochial School was founded in 1830, located on the south side of the pond, where All Saints' Hall currently stands. Pupils at the school ranged in age from 5 to 13 and were all educated together. The building was also sometimes used for church services, before the construction of All Saints church in 1865. When the new school was built in 1903 the old school became a dining room and library. It served as a mess hall during WWI before being demolished in 1938. | 19th-century | 1st edition Ordnance Survey Map, c.1855, 25-inch scale; Durham, 4 1839 Tithe DDR/EA/TTH/1/252 CVA landscape and building survey 2013-14; 'Cleadon's Schools', Kathleen Robinson (2014), unpublished report | |

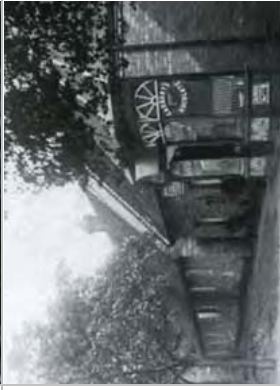
| CS31 | The Georgian Cottages | NZ 38378 62343 | Two blocks of terraced cottages, separated by a narrow lane, on the south side of Front Street. Probably built as worker's cottages for either Bainbridge Farm or Cleadon House Estate. Demolished in the 1960s but the western end of the range survives, occupied in part by a travel agent's and a saddlery shop. | 18th-century | 1st edition Ordnance Survey Map, c.1855, 25-inch scale; Durham, 4 1839 Tithe DDR/EA/TTH/1/252 CVA landscape and building survey 2013-14 | |

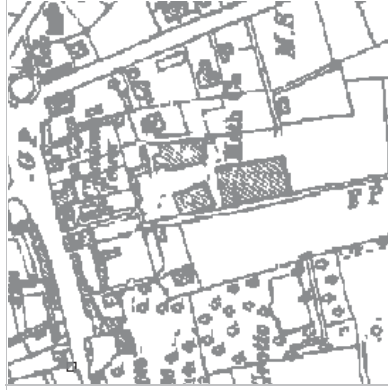
| CS33 | Cleadon Nursery | NZ 38464 62215 | Cleadon Nursery, first founded in the late 19th Century, is referenced in a sale notice of 1893. It expanded considerably in the early 20th Century to occupy much of the land to the west of Cleadon House, behind the Front Street properties. Owned in the 20th Century by the Groves family. | 20th-century, but probably 19th-century in origin. | Cleadon House sale notice 1893; 3rd edition 6-inch scale 1919; Aerial photograph c.1950 | |

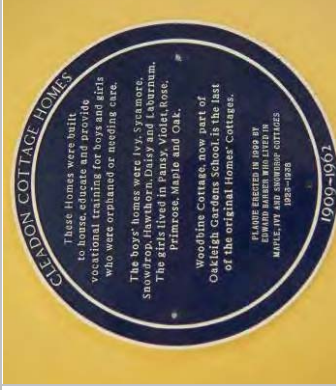
| CS34 | Cleadon Cottage Homes | NZ 38568 62922 | Cleadon Cottage Homes. Children's home built in 1909 and operating until 1962. Housed approx. 200 orphaned or abandoned children. Served as a hutment camp in 1909. A commemorative plaque to those from the Homes who served in the war can be seen on the village war memorial. There is also a blue plaque temporarily stored at the Village Community Room. | 20th-century | 3rd edition 6-inch scale 1919; CVA landscape and building survey 2013-14; Brian Bage. <i>pers.com</i> | |

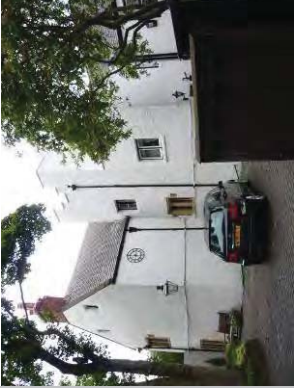
| HER No | Site Name | NGR | Description | Period | Sources | Photo |
|---|---|---|---|---|---|---|
| 964<br>(and 8026) | Cleadon tower | NZ 385 624 | Cleadon Tower is believed to be mentioned as early as 1587 and is perhaps rather a rare instance of a tower standing on a copyhold estate. The tower was taken down by Richard Pemberton, Esq. in the late 18th Century. The current 'tower' dates to 1890, although the surrounding buildings are earlier.. | Medieval | R. Surtees, 1820, History...of Durham, II, 55 and n.<br>1839 Tithe DDR/EA/TTH/1/252<br><b>Grade II Listed</b> (List No. 1025211)<br>CVA Building Survey but NEVAG Cleadon Tower Building Survey NAA & NEVAG Rpt 15-03. | |

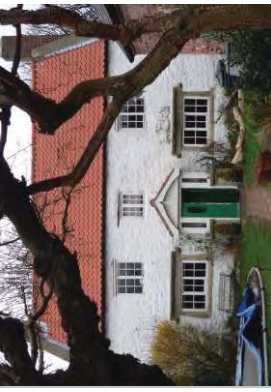
| HER No | Site Name | NGR | Description | Period | Sources | Photo |
|---|---|---|---|---|---|---|
| 8051 | Front Street, No. 11 | NZ 3850 6243 | Briar Cottage House, a mid C17, grade II listed building. Roughly squared coursed limestone, roof of pantiles. 2 storeys, 3 bays. Central half-glazed door with blank wall over between 3-light stone- mullioned windows with hood-moulds; 2 mullioned windows of 2 lights with hood-moulds at first floor. | 17th-century | Department of National Heritage, List of Buildings of Special architectural or Historic Interest, 3/19<br>1839 Tithe DDR/EA/TTH/1/252<br>CVA Building Survey 2013<br><b>Grade II Listed Building</b> | |

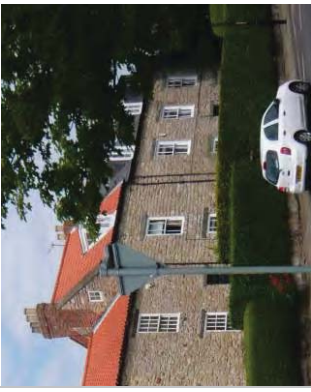
| HER No | Site Name | NGR | Description | Period | Sources | Photo |
|---|---|---|---|---|---|---|
| 8048 | Front Street, No. 1 | NZ 3854 6242 | Grade II listed farmhouse and hind cottage. Late C17/early C18. Coursed squared limestone, the main house thinly rendered; roof of Welsh slates to the main house, pantiles to the cottage. Main house: 2 storeys, 3 bays; central boarded door with oblong fanlight, sash windows at either side on ground floor; first floor has 2 sash windows and blocked narrow central window. Roof has 3 segment-headed dormers blocked with plywood at time of survey; 2 end brick chimneys. Cottage-: 2 storeys, 2 bays; one sash window at left; at right, one blocked narrow window on first floor. | 17th-century | Department of National Heritage, List of Buildings of Special architectural or Historic Interest, 3/15<br><b>Grade II Listed Building</b> (List No. 1025250)<br>1839 Tithe DDR/EA/TTH/1/252<br>South Tyneside Council, 2007, Cleadon Conservation Area Character Appraisal<br>CVA Building Survey 2013 | |

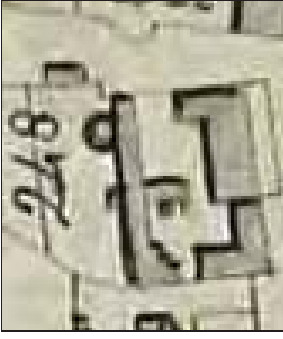
| HER No | Site Name | NGR | Description | Period | Sources | Photo |
|---|---|---|---|---|---|---|
| 12762 | Burdon Farm | NZ 3853 6243 | Burden's Farm lay north of the village pond. Some farm buildings still survive. | 17th-century (possibly earlier) | South Tyneside Council, 2007, Cleadon Conservation Area Character Appraisal, page 8<br>1839 Tithe DDR/EA/TTH/1/252<br>1st edition Ordnance Survey Map, c.1862, 6-inch scale, Durham, 3<br>CVA Building Survey 2014 | |

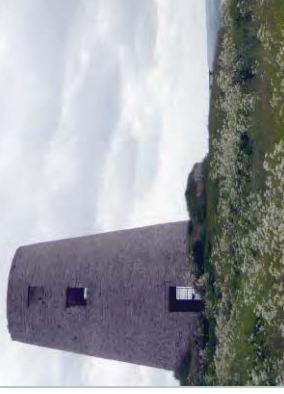
| HER No | Site Name | NGR | Description | Period | Sources | Photo |
|---|---|---|---|---|---|---|
| 1587 | Cleadon Windmill | NZ 3893 6318 | 18th-century tower mill built of coursed limestone rubble rising from a low mound contained by a retaining wall of limestone. The tower stands roofless with cap and sails removed but the stone shell is intact with one or two floor joists still in place. All the openings have dressed sandstone outer and timber inner lintels. Part of the cugged track on which the cap of the windmill turned is still visible. | 17th-century in origin - current building date to late 18th-century | I. Ayris & P. Jubb, 1987, Tower Mills of South Tyneside<br>I. Ayris & S.M. Linsley, 1994, A Guide to the Industrial Archaeology of Tyne and Wear<br><b>Grade II Listed Building (List No. 1025192)</b><br>1839 Tithe DDR/EA/TTH/1/252<br>CVA Cleadon Mill Excavations – NAA Report No. 15-02<br>CVA landscape and building survey 2013-14 | |

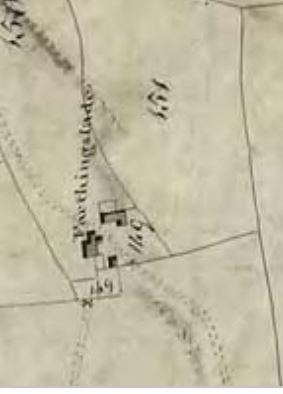
| HER No | Site Name | NGR | Description | Period | Sources | Photo |
|---|---|---|---|---|---|---|
| 965 | Farding Slade Farm | NZ 3920 6429 | In 1647 Elizabeth, widow of Robert Chambers, held land etc. listed under the heading "Whitburne cum Cleyton Copyholds". This land included "16 riggs of land in Cleadon in a certain place there called Farthing Slayde". The status of this place in the mid C17 is unknown, and also, indeed, whether it might be medieval. It underwent extensive modification and rebuilding in the mid 19th Century when occupied by Robert Jefferson. Site was cleared in the 1980s | 17th-century? | D.A. Kirby, 1972, Parliamentary Surveys of the Bishopric of Durham, Surtees Society, II, 185, p. 50<br>W. Parson & W. White, 182, Directory of Durham and Northumberland, II, pp. 199-200<br>Ordnance Survey maps, 1862, 1st ed. 6, Durham IV<br>1839 Tithe DDR/EA/TTH/1/252<br>CVA Landscape Survey 2013 | |

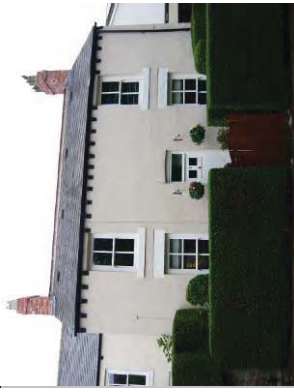
| HER No | Site Name | NGR | Description | Period | Sources | Photo |
|---|---|---|---|---|---|---|
| 12777 | Sunnyside Lane,<br>No. 5 | NZ 3854 6245 | Late 18th- to early 19th- century house probably incorporating the remains of earlier structures. Rendered front elevation that returns along the first floor of the south facing gable. A pleasant building with brick corbelling supporting rainwater goods, brick quoins and timber four-pane sliding sash windows on the first floor and three-over-two on the ground floor. | 18th-century | South Tyneside Council, 2007, Cleadon Conservation Area Character Appraisal, page 30<br>CVA Building Survey 2014<br>1839 Tithe DDR/EA/TTH/1/252 | |

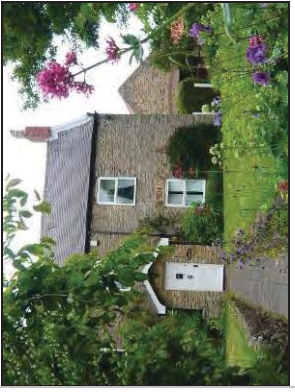
| HER No | Site Name | NGR | Description | Period | Sources | Photo |
|---|---|---|---|---|---|---|
| 9606 | Cleadon Lane,<br>No. 1, East Farm<br>and boundary<br>walls | NZ 3857 6242 | The farm comprised two yard areas and a collection of outbuildings including a gin-gang. The late 18th and early 19th Century farmhouse (NZ 3857 6242) is built in irregular coursed rubble with irregular stone quoins. It has new window openings and window inserts that are flush to the wall. The roof is Welsh slate with high raised gables.<br>The farmhouse is surrounded by an attractive stone boundary wall and is a prime example of the use of the local limestone and glacial erratics as a building material. The new East Farm development is a courtyard with modern houses around it. | 18th-century<br>(possibly<br>medieval in<br>origin) | Tyne and Wear Specialist<br>Conservation Team, March 1992,<br>Other Buildings of Acknowledged<br>Architectural Quality or Historic<br>Significance (South Tyneside UDP<br>Appendix ENV (B)); South Tyneside<br>Council, March 2007, Cleadon<br>Conservation Area Character<br>Appraisal Tyneside Local List Review<br>2011, LSHA/147/C<br>1839 Tithe DDR/EA/TTH/1/252<br>CVA Building Survey 2014 | |

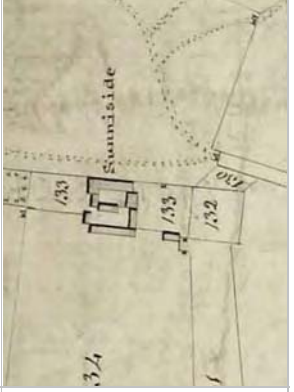
| HER No | Site Name | NGR | Description | Period | Sources | Photo |
|---|---|---|---|---|---|---|
| 9099 | Sunnyside Farm | NZ 3864 6342 | A discreet group of functional buildings in local limestone and slate. In good condition with recent lime-rich pointing. Single high brick arched entrance into the courtyard. The farmhouse is a simple square hip roofed building with regular fenestration. Farm appears on 1839 tithe map and was one of the post-enclosure farmsteads established in the late 17th Century. | 18th-century<br>(probably 17th<br>century in origin) | South Tyneside Council, 2007,<br>Cleadon Hills Conservation Area<br>Character Appraisal<br>CVA Building Survey 2014 | |

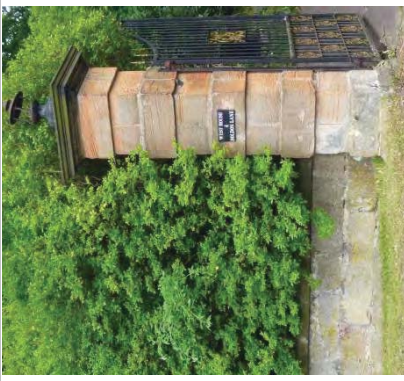
| HER No | Site Name | NGR | Description | Period | Sources | Photo |
|---|---|---|---|---|---|---|
| 8027 | Cleadon House boundary walls and gate piers | NZ3831762324 | Cleadon House wall and gate piers. Arising from front right of the house is a high brick wall with 3 banded square piers and a garden entrance; this connects with a high garden wall, extending the width of the garden, of roughly squared coursed limestone rubble with a triple moulded brick coping. The entrance from the street is formed by a low wall of brick with stone coping, continuing along through 3 square brick piers with plinths, in which are 2 ashlar gate piers with overhanging cornices. Original iron gates and railings have been removed. | 18th-century | English Heritage National List<br><b>Grade II Listed Building (List No. 025213)</b><br>1st edition Ordnance Survey Map, c.1862, 6-inch scale<br>1839 Tithe DDR/EA/TTH/1/252<br>CVA Building Survey 2014 | |

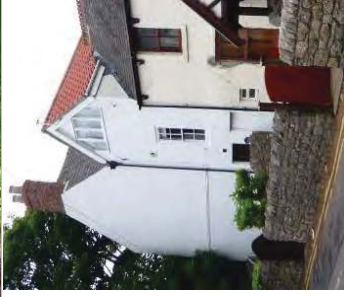
| HER No | Site Name | NGR | Description | Period | Sources | Photo |
|---|---|---|---|---|---|---|
| 12778 | Cleadon, Sunnyside Lane, No. 1 | NZ 3854 6243 | Possibly once a single storey cottage of 17th- or 18th-century date, heightened in the 19th Century to two storeys. The windows are timber sliding sash. The first floor window on the side elevation has been raised. There is a central chimney stack. The open sided timber porch on the front is modern. Building has been recently rendered. | 18th-century? | South Tyneside Council, 2007, Cleadon Conservation Area Character Appraisal, page 30<br>1839 Tithe DDR/EA/TTH/1/252<br>CVA Buildings Survey | |

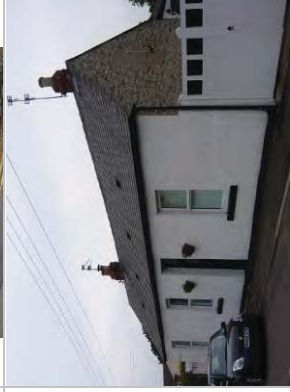
| HER No | Site Name | NGR | Description | Period | Sources | Photo |
|---|---|---|---|---|---|---|
| 12774 | Sunnyside Lane, No. 7 | NZ 3853 6246 | A single storey cottage, possibly 18th-century in date, rendered and painted white. Appears to be a pair of cottages converted into one. The projecting stone cills have been painted black. New windows have been inserted. The roof is Welsh slate, with brick chimney stacks and terracotta pots. Probably associated with the Old Hall garden, which extended to the west. Perhaps a gardener's cottage or workshop. | 18th-century? | South Tyneside Council, 2007, Cleadon Conservation Area Character Appraisal, pages 28-29<br>CVA Building Survey 2014 | |

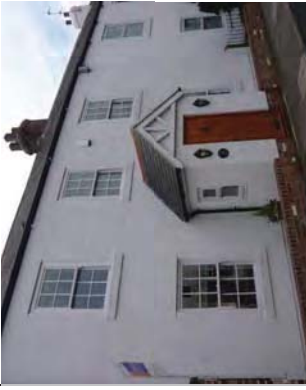
| HER No | Site Name | NGR | Description | Period | Sources | Photo |
|---|---|---|---|---|---|---|
| 12791 | Old Post Office | NZ 3842 6234 | The post office is slotted into a terrace of late 19th-century houses that are rendered. They have replacement windows and timber shutters that clutter the elevations. | 18th-century? | South Tyneside Council, 2007, Cleadon Conservation Area Character Appraisal, page 47 | |

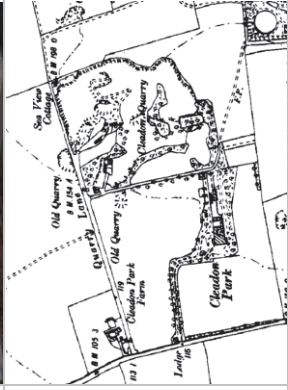
| HER No | Site Name | NGR | Description | Period | Sources | Photo |
|---|---|---|---|---|---|---|
| 2399 | Cleadon Park Limestone Quarry | NZ 3845 6398 | Cleadon Quarry. The precise extents of the site are unclear on the 1st edition OS mapping, which does however show a Lime Kiln within the site. Extensive working shown on first edition map, quarry remained in used until the mid 20th Century. Now a park and housing estate. | 19th-century – founded earlier, perhaps 17th-century. | 1st edition Ordnance Survey Map, c.1862, 6-inch scale, Durham, 4 | |

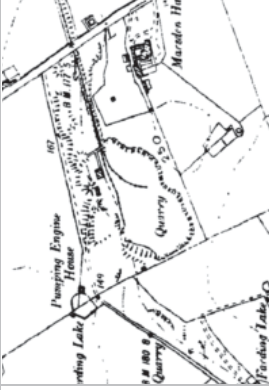
| HER No | Site Name | NGR | Description | Period | Sources | Photo |
|---|---|---|---|---|---|---|
| 2482 (and 2404) | Marsden Old Quarry | NZ 3957 6453 | Quarry at Marsden, which is first shown on the 2nd edition OS map but probably developed from an earlier quarry (HER 2404), shown on the first edition OS. It was served by railway HER 2483. In 2004 during excavation work to strip topsoil from the limestone adjacent to Marsden Old Quarry Local Nature Reserve, a series of what looked like boreholes were found covering an area of approximately 10m x 10m. T | 19th-century | 2nd edition, Ordnance Survey map, 1898, 6-inch scale, Durham, 4, SW | |

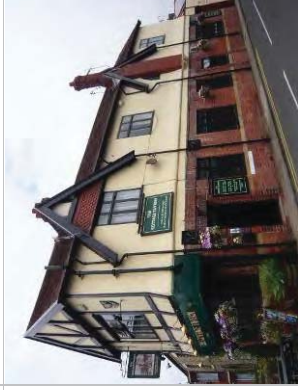
| HER No | Site Name | NGR | Description | Period | Sources | Photo |
|---|---|---|---|---|---|---|
| 12779 | North Street, The Cottage Tavern | NZ 3844 6249 | A 19th-century public house. It was extended at its western end in the later 20th Century. Pitched gables have been added to the south elevation and the first floor rendered, painted white and timber boarding added. | 19th-century | South Tyneside Council, 2007, Cleadon Conservation Area Character Appraisal, page 31 | |

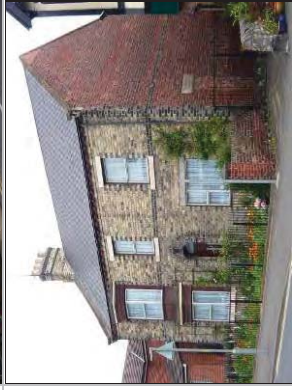
| HER No | Site Name | NGR | Description | Period | Sources | Photo |
|---|---|---|---|---|---|---|
| 12780 | Cleadon, Shields Road, Grove House | NZ 3842 6250 | Late 19th-century house built of firebrick formerly incorporated a butchers shop with slaughter house behind. A painted stone lintel above a blocked doorway on the southern gable is inscribed 'H Burdon Butcher'. The two storey house is double fronted with a full height timber re-clad bay to the left side and a new large window inserted on the ground floor to the right side. All the windows are replacements. A stone boundary wall continues north behind Grove House. | 19th-century | 2nd edition, Ordnance Survey map, 1898, 6-inch scale, Durham, 8, NW CVA Building Survey 2014 | |

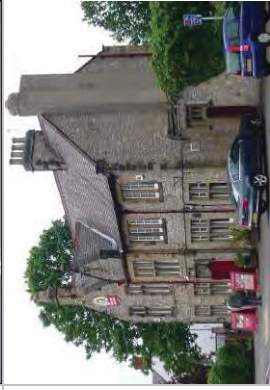
| HER No | Site Name | NGR | Description | Period | Sources | Photo |
|---|---|---|---|---|---|---|
| 12788 | The Britannia Inn | NZ 3842 6240 | Built in 1896 to replace an earlier coaching inn of the same name. Extravagant design in limestone with sandstone quoins, window and door surrounds. It has been extended to the south to more than double its original footprint. | 19th-century | South Tyneside Council, 2007, Cleadon Conservation Area Character Appraisal, page 44<br>2nd edition, Ordnance Survey map, 1898, 6-inch scale<br>CVA Building Survey 2014 | |

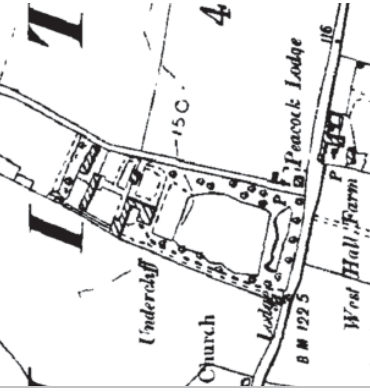
| HER No | Site Name | NGR | Description | Period | Sources | Photo |
|---|---|---|---|---|---|---|
| 8163 | Cleadon Lane, Undercliff | NZ 3897 6243 | House, now 3 separate dwellings. Built circa 1853 for the Allison family. Brick with sandstone dressings; Welsh slate roof. 2 storeys; 3 bays on west front defined by 4 Tuscan giant pilasters with stone plinths and capitals. Hipped roof, square brick chimneys with stone bands and cornices. Plain 2-storey, 4-bay wing on east has 2-storey, 2-bay return forming a courtyard with a range consisting of a passage, a house of 2 low storeys, a cottage, a carriage entrance and a coach house. A curved brick wall extending from the north-west corner of the house to the courtyard entrance has, on the courtyard side, a brick mounting block with 3 stone steps. | 19th-century | Department of National Heritage, List of Buildings of Special architectural or Historic Interest, 3/7<br><b>Grade II Listed Building</b> (List No: 1355077)<br>CVA Building Survey 2014 | |

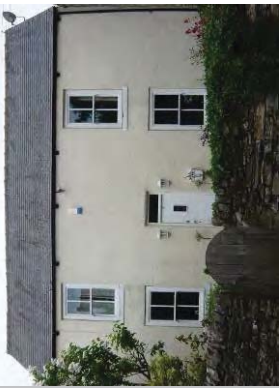
| HER No | Site Name | NGR | Description | Period | Sources | Photo |
|---|---|---|---|---|---|---|
| 12776 | Sunnyside Lane, No. 3 | NZ 3854 6244 | A two-storey house set back from its neighbours. Probably 19th-century incorporating remnants of earlier structures. It was once attached to a range of structures around a farmyard. A simple double fronted traditional two-up two-down property. It is rendered white. The lower cills are stone. The chimney stacks are located at eaves height creating a flat ridge line. The windows are replacements. A drive between Nos. 1 and 3 leads into the former farmyard. | 19th-century | South Tyneside Council, 2007, Cleadon Conservation Area Character Appraisal, page 30 | |

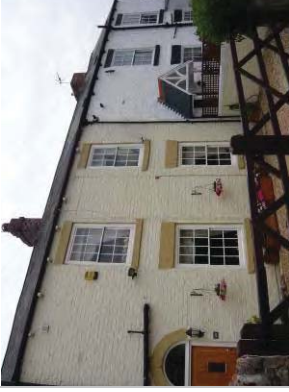
| HER No | Site Name | NGR | Description | Period | Sources | Photo |
|---|---|---|---|---|---|---|
| 12792 (inc. 12767) | Front Street, Nos. 18 to 22 | NZ 3842 6232 | Nursery Lane once led to extensive areas of glass houses behind Cleadon Tower. Today it still contains an extremely attractive terrace of houses. Built in 1860, the houses are rendered. Some retain their original six-over-six windows and doors. Sections of stone boundary wall survive. The houses face onto an unattractive garage court. | 19th-century | South Tyneside Council, 2007, Cleadon Conservation Area Character Appraisal, page 47<br>CVA Building Survey 2014 | |

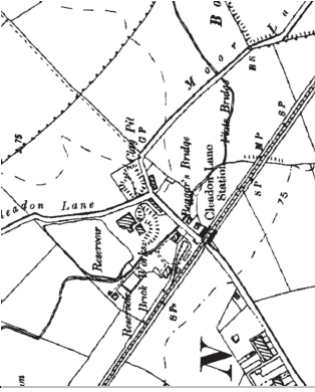
| HER No | Site Name | NGR | Description | Period | Sources | Photo |
|---|---|---|---|---|---|---|
| 2577 | Cleadon Junction<br>Brick Works | NZ 3637 6230 | Brick Works. This was not shown on the 1st edition OS mapping, so was opened after 1862. 1894-1938 | 20th-century | 2nd edition, Ordnance Survey map, 1898, 6-inch scale, Durham, 8, NW Davison, P J, 1986. Brickworks of the North East, 122 site 24. | |

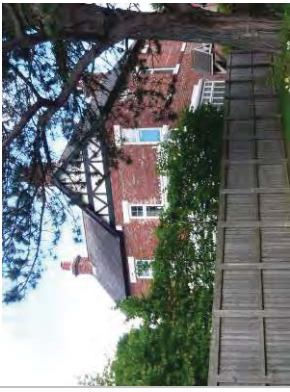
| HER No | Site Name | NGR | Description | Period | Sources | Photo |
|---|---|---|---|---|---|---|
| 12801 | Cleadon Plantation | NZ 380 620 | Cleadon Plantation, a landscaped estate, was built over Cleadon Moor and Little Moor to the west of the historic core from the start of the 20th Century. It lies over an undulation of Cleadon Hills falling gently from the north east to south west. The estate comprised a collection of large houses in generous gardens using well established tree and hedge lines to create a sense of enclosure and privacy. The quality of pre-First World War housing stock is outstanding. Houses were approached by drives that cut across the gardens and were south facing to take advantage of views over the sloping gardens. Some houses had short garden terraces. This echoes the estates like Regent's Park in | 20th-century | South Tyneside Council, 2007, Cleadon Conservation Area Character Appraisal, pages 55-86<br>CVA Buildings Survey 2014 | |

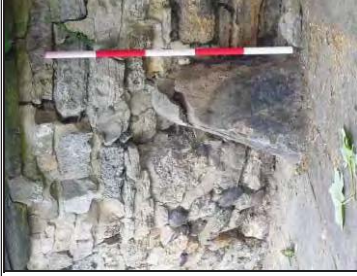
| Survey No. | Site Name | NGR | Description | Period | Sources | Photo |
|---|---|---|---|---|---|---|
| CS1 | Guard stone | NZ 38540 62422 | Guard stone at the junction of Front Street and Sunnyside Lane, adjacent to Burdon Farm. These were positioned to protect walls from damage from carts or agricultural equipment. Possibly contemporary with the wall and may be 18th-century. Top of the stone is damaged. Consideration should be given to repairing this to prevent further decline. | 18th-century? | CVA Building Survey 2014 | |

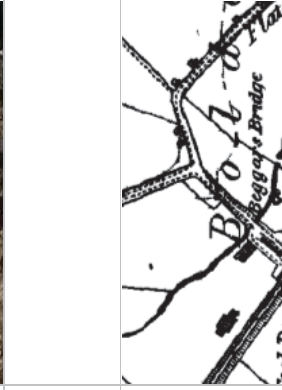
| CS23 | Cleadon Lane Brick Works | NZ 3717 6154 | Same as HER 2580. | 19th-century | 1st edition Ordnance Survey Map, c.1862, 6-inch scale; Durham, 4 CVA landscape and building survey 2013-14 | |

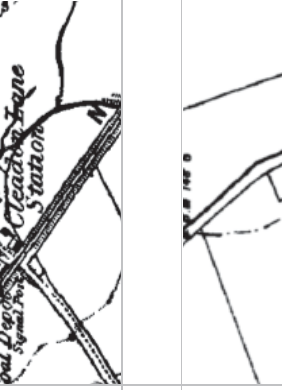
| CS24 | Cleadon Lane Station | NZ 3717 6154 | Station first associated with the Brandling Railway and later taken over by the NER and renamed East Boldon Station. Today forms part of the Metro line but little of the original fabric of the station survives. | 19th-century | 1st edition Ordnance Survey Map, c.1862, 6-inch scale; Durham, 4 CVA landscape and building survey 2013-14 | |

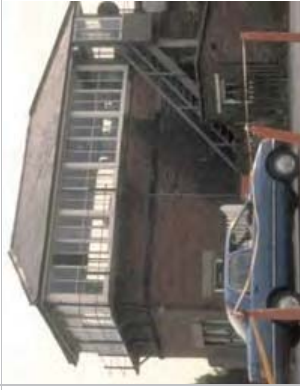
| CS27 | Tilsheds signal box | NZ 3641 6211 | Signal box was first opened in 1875 to control the crossover and siding on the Tyne Dock branch of NER railway, which separated from the Sunderland to Newcastle main line a few metres south at Cleadon Junction. In addition, the signalman monitored the level crossing, opening and closing the wheel-worked gates to let people and carriages along Tilsheds Lane. | 19th-century | 2nd edition Ordnance Survey Map, c.1898, 6-inch scale; Durham, 4 CVA landscape and building survey 2013-14 | |

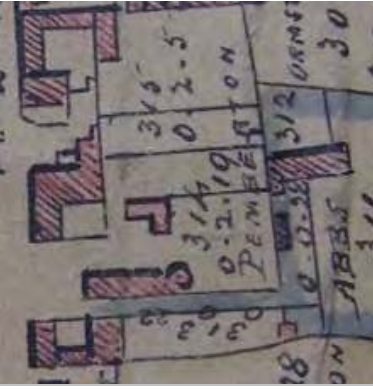
| CS28 | Bainbridge Farm | NZ 38450 62320 | Farm shown on 1839 tithe, farmed by George Bainbridge on land belonging to Richard Pemberton. Originally located on the east side of Nursery Lane, formerly known as Dog-kennel Lane. One of four farms in the village in the 19th Century and potentially medieval in origin. | Medieval? | 1st edition Ordnance Survey Map, c.1862, 6-inch scale; Durham, 4 1839 Tithe DDR/EA/TTH/1/252 CVA landscape and building survey 2013-14 | |

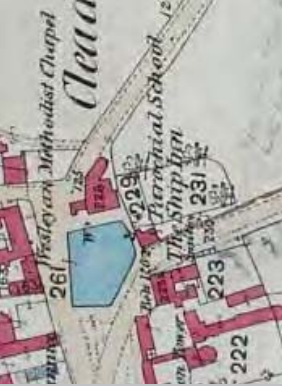
| CS29 | The Cluster | NZ 3856 6238 | Group of cottages that formerly stood to the east of the village pond, clustered around the wellhead. Demolished in the 20th Century. | 18th-century? | 1st edition Ordnance Survey Map, c.1862, 25-inch scale; Durham, 4 1839 Tithe DDR/EA/TTH/1/252 CVA landscape and building survey 2013-14 | |

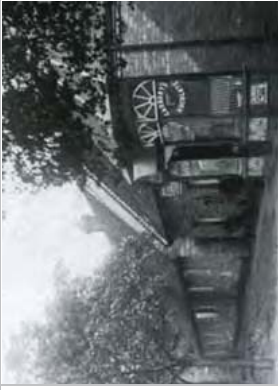
| CS31 | The Georgian Cottages | NZ 38378 62343 | Two blocks of terraced cottages, separated by a narrow lane, on the south side of Front Street. Probably built as worker's cottages for either Bainbridge Farm or Cleadon House Estate. Demolished in the 1960s but the western end of the range survives, occupied in part by a travel agent's and a saddlery shop. | 18th-century | 1st edition Ordnance Survey Map, c.1855, 25-inch scale; Durham, 4 1839 Tithe DDR/EA/TTH/1/252 CVA landscape and building survey 2013-14 | |

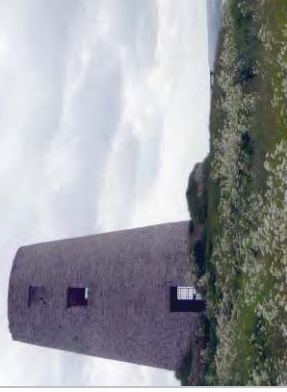
| HER No | Site Name | NGR | Description | Period | Sources | Photo |
|---|---|---|---|---|---|---|
| 1587 | Cleadon Windmill | NZ 3893 6318 | 18th-century tower mill built of coursed limestone rubble rising from a low mound contained by a retaining wall of limestone. The tower stands roofless with cap and sails removed but the stone shell is intact with one or two floor joists still in place. All the openings have dressed sandstone outer and timber inner lintels. Part of the cugged track on which the cap of the windmill turned is still visible. | 17th-century in origin - current building date to late 18th-century | I. Ayris & P. Jubb, 1987, Tower Mills of South Tyneside<br>I. Ayris & S.M. Linsley, 1994, A Guide to the Industrial Archaeology of Tyne and Wear<br><b>Grade II Listed Building (List No. 1025192)</b><br>1839 Tithe DDR/EA/TTH/1/252<br>CVA Cleadon Mill Excavations – NAA Report No. 15-02<br>CVA landscape and building survey 2013-14 | |

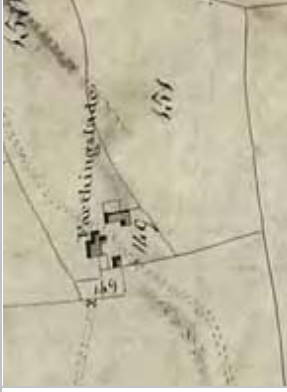
| HER No | Site Name | NGR | Description | Period | Sources | Photo |
|---|---|---|---|---|---|---|
| 965 | Farding Slade Farm | NZ 3920 6429 | In 1647 Elizabeth, widow of Robert Chambers, held land etc. listed under the heading "Whitburne cum Cleyton Copyholds". This land included "16 riggs of land in Cleadon in a certain place there called Farthing Slayde". The status of this place in the mid C17 is unknown, and also, indeed, whether it might be medieval. It underwent extensive modification and rebuilding in the mid 19th Century when occupied by Robert Jefferson. Site was cleared in the 1980s | 17th-century? | D.A. Kirby, 1972, Parliamentary Surveys of the Bishopric of Durham, Surtees Society, II, 185, p. 50<br>W. Parson & W. White, 182, Directory of Durham and Northumberland, II, pp. 199-200<br>Ordnance Survey maps, 1862, 1st ed. 6, Durham IV<br>1839 Tithe DDR/EA/TTH/1/252<br>CVA Landscape Survey 2013 | |

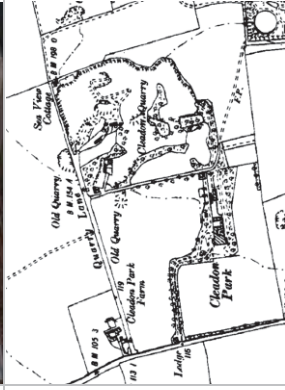
| HER No | Site Name | NGR | Description | Period | Sources | Photo |
|---|---|---|---|---|---|---|
| 2399 | Cleadon Park Limestone Quarry | NZ 3845 6398 | Cleadon Quarry. The precise extents of the site are unclear on the 1st edition OS mapping, which does however show a Lime Kiln within the site. Extensive working shown on first edition map, quarry remained in used until the mid 20th Century. Now a park and housing estate. | 19th-century – founded earlier, perhaps 17th-century. | 1st edition Ordnance Survey Map, c.1862, 6-inch scale, Durham, 4 | |

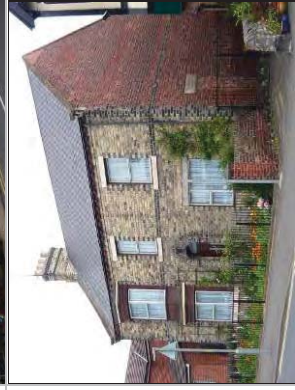
| HER No | Site Name | NGR | Description | Period | Sources | Photo |
|---|---|---|---|---|---|---|
| 12780 | Cleadon, Shields Road, Grove House | NZ 3842 6250 | Late 19th-century house built of firebrick formerly incorporated a butchers shop with slaughter house behind. A painted stone lintel above a blocked doorway on the southern gable is inscribed 'H Burdon Butcher'. The two storey house is double fronted with a full height timber re-clad bay to the left side and a new large window inserted on the ground floor to the right side. All the windows are replacements. A stone boundary wall continues north behind Grove House. | 19th-century | 2nd edition, Ordnance Survey map, 1898, 6-inch scale, Durham, 8, NW CVA Building Survey 2014 | |

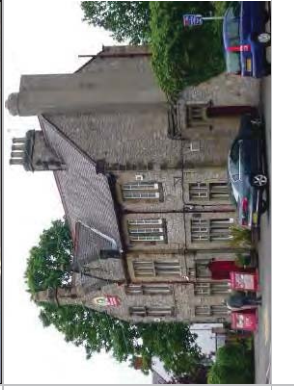
| HER No | Site Name | NGR | Description | Period | Sources | Photo |
|---|---|---|---|---|---|---|
| 12788 | The Britannia Inn | NZ 3842 6240 | Built in 1896 to replace an earlier coaching inn of the same name. Extravagant design in limestone with sandstone quoins, window and door surrounds. It has been extended to the south to more than double its original footprint. | 19th-century | South Tyneside Council, 2007, Cleadon Conservation Area Character Appraisal, page 44<br>2nd edition, Ordnance Survey map, 1898, 6-inch scale<br>CVA Building Survey 2014 | |

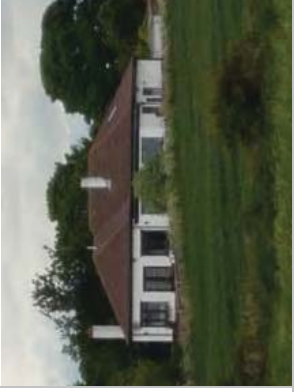
| HER No | Site Name | NGR | Description | Period | Sources | Photo |
|---|---|---|---|---|---|---|
| 12769 | Cleadon Lane,<br>Undercliff Lodge | NZ 3886 6228 | Gate lodge to Undercliff (HER 8163). It has been extended along its western elevation with the addition of a flat roofed building in the 1970s, which is painted white. The extension is inappropriate. | 19th-century | South Tyneside Council, 2007, Cleadon Conservation Area Character Appraisal, pages 22-23 | |

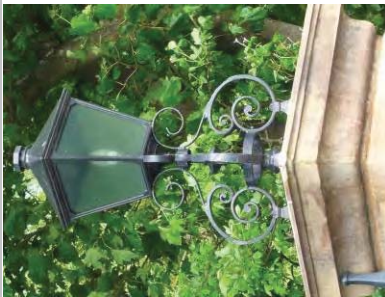
| HER No | Site Name | NGR | Description | Period | Sources | Photo |
|---|---|---|---|---|---|---|
| 9610 | Cleadon Lane,<br>Undercliff,<br>boundary wall | NZ 3891 6226 | See above. | 19th-century | Tyne and Wear Specialist Conservation Team, March 1992, Other Buildings of Acknowledged Architectural Quality or Historic Significance (South Tyneside UDP Appendix ENV (B))<br>CVA Building Survey 2014 | |

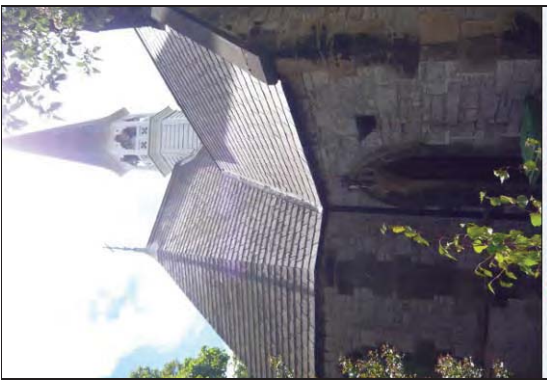
| HER No | Site Name | NGR | Description | Period | Sources | Photo |
|---|---|---|---|---|---|---|
| 8047 | Cleadon Lane, Church of All Saints | NZ 3858 6235 | Parish church. 1869 by R J Johnson, south aisle 1907. Snecked limestone rubble with sandstone ashlar quoins and dressings, high-pitched roofs of Welsh slate with stone coping to nave and aisle, in Early English style. Nave with south aisle and south porch, chancel with 3-sided apse, north transept. Transept has a 2-light window in the gable and an east door with flower stops to a drip-mould. Roof has stone cross finial at west, iron at east; above the chancel a hexagonal timber bellcote with Welsh slate spirelet and iron finial; chimney at the transept gable.<br>Interior: south arcade of 2 wide bays, paintings of Garden of Gethsemane by J Eadie Read of Newcastle c.1914 in spandrels; apse paintings of Christ on the Cross and Christ in Majesty by Michael Hoare of Folkestone in 1967; 2-light west Window, war memorial by L C Evetts of Newcastle in 1948. | 19th-century | Department of National Heritage, List of Buildings of Special architectural or Historic Interest, 3/8 Grade II Listed Building (List No: 1025247)<br>Chadwick, M (1994) unpublished report<br>CVA Building Survey 2014 | |

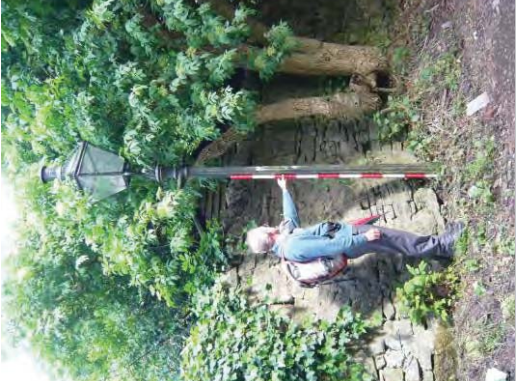
| HER No | Site Name | NGR | Description | Period | Sources | Photo |
|---|---|---|---|---|---|---|
| 8114, 8117 | Cleadon, West Park Road, No. 8 and No. 4 gas lamps | NZ 3813 6621<br>NZ 3812 6223 | Gas street lamp. Late C19. Cast iron fluted standard, supporting square glazed lap with circular ventilator cap. | 19th-century | Department of National Heritage, List of Buildings of Special architectural or Historic Interest, 103<br>CVA Building Survey 2014 | |

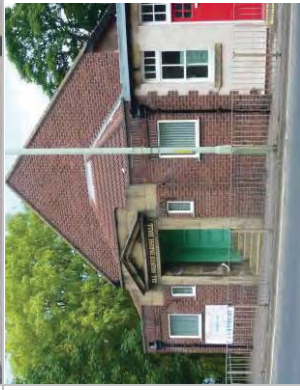
| HER No | Site Name | NGR | Description | Period | Sources | Photo |
|---|---|---|---|---|---|---|
| 12783 | Cleadon, All Saints Church, church hall (location of Parochial School) | NZ 3854 6236 | Inter-war church hall. Brick with shallow buttress supports on the north and south elevations. Rendered and incised to look like masonry. Original windows. Slate roof. Little ornamentation except the front porch with a concrete doorway with simple triangular pediment with 'ALL SAINTS CHURCH HALL' painted across it. The church hall is situated on the site of the old Parochial School, which served as the village hall after the school next door was built in 1903 | 20th-century | South Tyneside Council, 2007, Cleadon Conservation Area Character Appraisal, page 38; SOUTH TYNESIDE LOCAL LIST REVIEW 2011, LSHA/160/C<br>CVA Buildings Survey 2014 | |

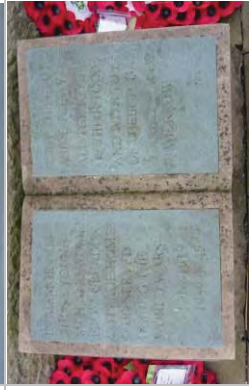
| HER No | Site Name | NGR | Description | Period | Sources | Photo |
|---|---|---|---|---|---|---|
| 11199 | Front Street, War Memorial (Cleadon Cottage Homes) | NZ 3844 6236 | Stone book with pages open on steps in front of an altar (HER 11198). Inscription of a pink panel: "IN MEMORY OF THOSE YOUNG MEN AND WOMEN FROM CLEADON COTTAGE HOMES WHO SERVED DURING THE WORLD WARS 1914-1919 1939-1945". | 20th-century | North East War Memorials Project Ref. C79.06 ( <a href="http://www.newmp.org.uk">www.newmp.org.uk</a> ); SOUTH TYNESIDE LOCAL LIST REVIEW 2011, LSHA/156/C | |

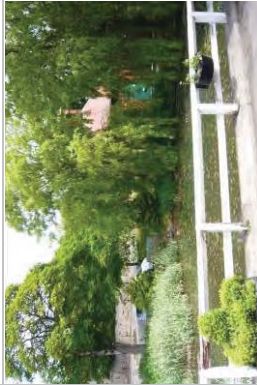
| HER No | Site Name | NGR | Description | Period | Sources | Photo |
|---|---|---|---|---|---|---|
| 12781 | Village pond | NZ 3853 6238 | The heart of the village and one of two ponds that used to serve Cleadon; a second header pond being located on Sunnyside Lane. The current pond was reduced in size when the road was widened in the 1960s | Medieval | South Tyneside Council, 2007, Cleadon Conservation Area Character Appraisal, pages 33-4;<br>SOUTH TYNESIDE LOCAL LIST REVIEW 2011, LSHA/151/C<br>1839 Tithe DDR/EA/TTH/1/252<br>CVA Landscape Survey 2013-14 | |

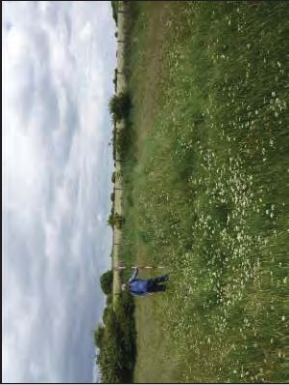
| HER No | Site Name | NGR | Description | Period | Sources | Photo |
|---|---|---|---|---|---|---|
| 975 | Cleadon Hill, army trenches | NZ 389 631 | On Cleadon Hill, west and south-west of the windmill, there are short, slightly curved, stretches of ditch with the upcast piled on one side. By oral tradition these were said to be army trenches, date of digging unknown. Some of the features in this area are definitely associated with the pre-1914 golf course but at least 4 and perhaps 5 could be WWI trenches, though not the classic zigzag networks. These notably face each other and are orientated east to west. Range from 28 to 12m long and are approx 2m wide with a raised bank on one side and shallow recess on the other. Majority of features probably relate to pre-war golf course extension. | WWI | Pers. Comm. P.R.M. Harbottle, 1993, Cleadon Hill trenches - Historic Environment Record<br>CVA landscape and building survey 2013-14 | |

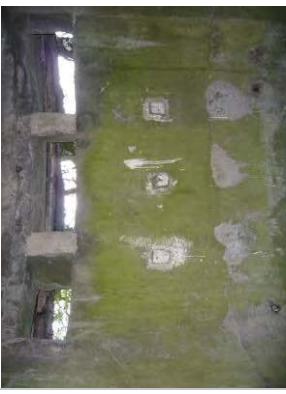
| HER No | Site Name | NGR | Description | Period | Sources | Photo |
|---|---|---|---|---|---|---|
| 4652 | Cleadon Hills, Pillbox | NZ 3913 6241 | Potential WWI pillbox constructed of concrete and brick and partially hidden in the hedgerow. | WWI? | Defence of Britain Project, 2002, Defence of Britain Database, S0002914; SOUTH TYNESIDE LOCAL LIST REVIEW 2011, LSHAV157/C<br>CVA landscape and building survey 2013-14<br>Roger Thomas pers com | |

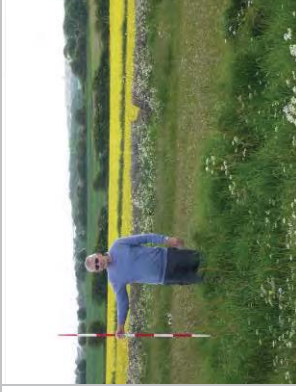
| CS7 | Earthworks adjacent to Cleadon Mill | NZ 3890 6321 | Oval enclosure, measuring 25m east to west and 13m north to south. Central depression with raised collar with stonework under the surface, suggesting a walled enclosure. Shape and proximity to Cleadon Mill Farm would suggest a pond but interior was not boggy and feature is not annotated as containing water on the 25-inch first edition OS map. Possibly a paddock or sheep stell. | 17th – 18th C? | 1st edition Ordnance Survey Map, c.1862, 6-inch scale, CVA landscape and building survey 2013-14 | |

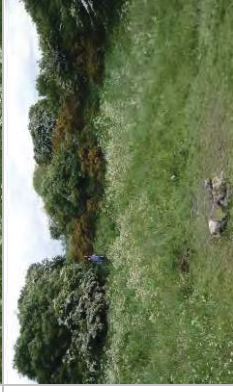
| CS8 | Limestone quarry | NZ 3906 6307 | Limestone Quarry, marked as Old on the 1st edition OS mapping so was out of use by 1862. Large amount of rubble found in the undergrowth, which would suggest a small structure, now demolished | 17th – 18th century? | 1st edition Ordnance Survey Map, c.1862, 6-inch scale, Durham, 4 | |

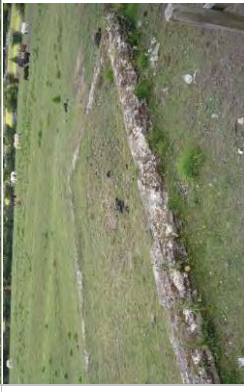
| CS9 | WWI officers barracks | NZ 3865 6236 | Footing of barrack block occupied by British and Canadian officers during WWII and associated with the searchlight battery. Footings survive well and can be clearly seen, building measures 20m x 30m, aligned along road. | WWII | Information from Maurice Chadwick CVA landscape and building survey 2013-14 | |

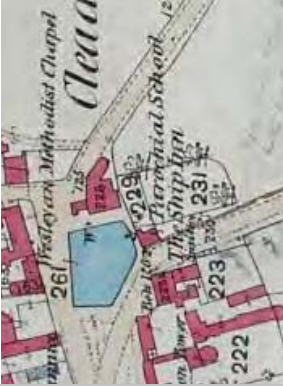
| CS29 | The Cluster | NZ 3856 6238 | Group of cottages that formerly stood to the east of the village pond, clustered around the wellhead. Demolished in the 20th Century. | 18th-century? | 1st edition Ordnance Survey Map, c.1862, 25-inch scale; Durham, 4 1839 Tithe DDR/EA/TTH/1/252 CVA landscape and building survey 2013-14 | |

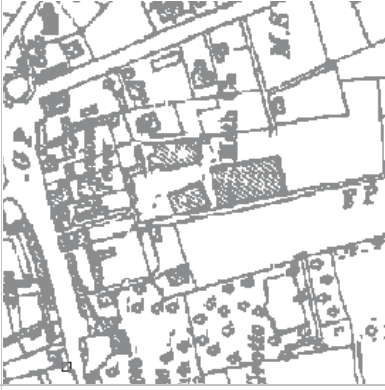
| CS33 | Cleadon Nursery | NZ 38464 62215 | Cleadon Nursery, first founded in the late 19th Century, is referenced in a sale notice of 1893. It expanded considerably in the early 20th Century to occupy much of the land to the west of Cleadon House, behind the Front Street properties. Owned in the 20th Century by the Groves family. | 20th-century, but probably 19th-century in origin. | Cleadon House sale notice 1893; 3rd edition 6-inch scale 1919; Aerial photograph c.1950 | |

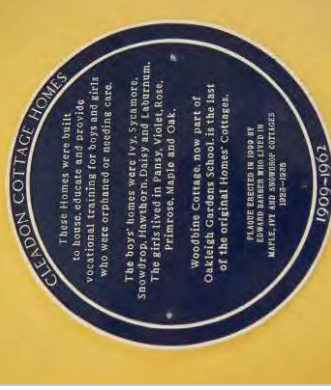
| CS34 | Cleadon Cottage Homes | NZ 38568 62922 | Cleadon Cottage Homes. Children's home built in 1909 and operating until 1962. Housed approx. 200 orphaned or abandoned children. Served as a hutment camp in 1909. A commemorative plaque to those from the Homes who served in the war can be seen on the village war memorial. There is also a blue plaque temporarily stored at the Village Community Room. | 20th-century | 3rd edition 6-inch scale 1919; CVA landscape and building survey 2013-14; Brian Bage. <i>pers.com</i> | |
